**TMH19**

**MANUAL FOR THE VISUAL  
ASSESSMENT OF ROAD  
STRUCTURES**

**PART B: VISUAL ASSESSMENT GUIDE**

**August 2020**

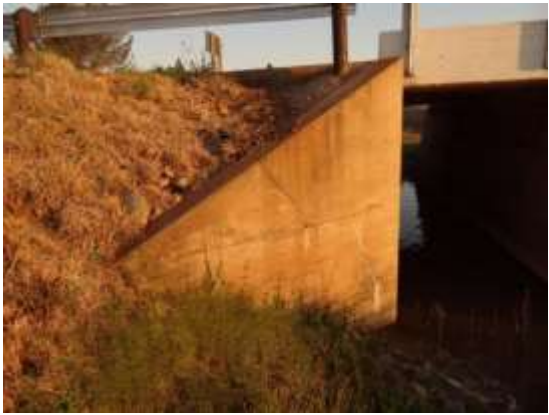
<b>Item 1: Approach Embankment Defect Photos</b>		
D = 1

Left DER-U 121-1		
Right DER-U 121-2		
	Erosion alongside bridge stone pitching	Erosion behind wing wall
D = 2	 	 
Left DER-U 222-3		
Right DER-U 222-2		
	Settlement of approach fill – 50 to 100mm	Erosion encroaching on road
D = 3	 	 
Left DER-U 323-4		
Right DER-U 333-3		
	Deep scour encroaching on road	Deep erosion behind wing wall
D = 4	 	 
Left DER-U 443-3		
Right DER-U 434-4		
	Major erosion of embankment	Deep scour, sides are vertical or overhanging

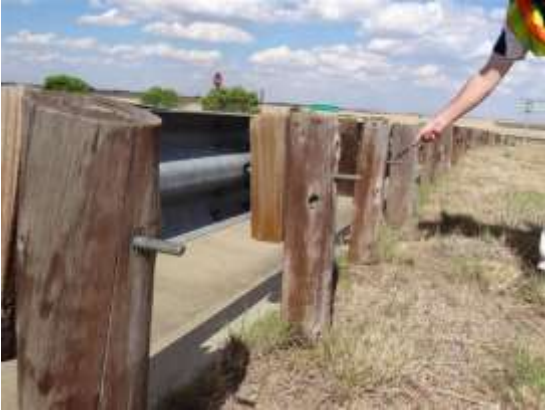
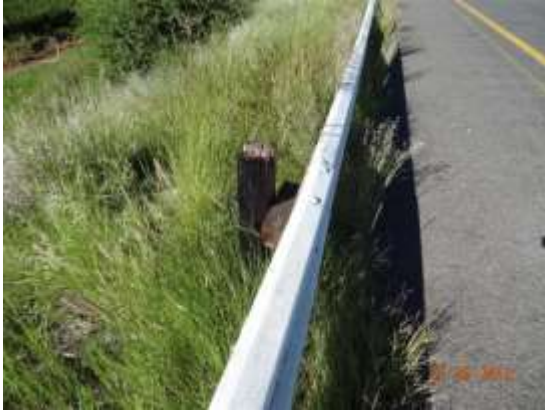
Item 2		Guardrail Defect Photos	
D = 1

Left DER-U 131-2			
Right DER-U 111-2			
	Missing fixing nuts	Reposition loose spacer block	
D = 2

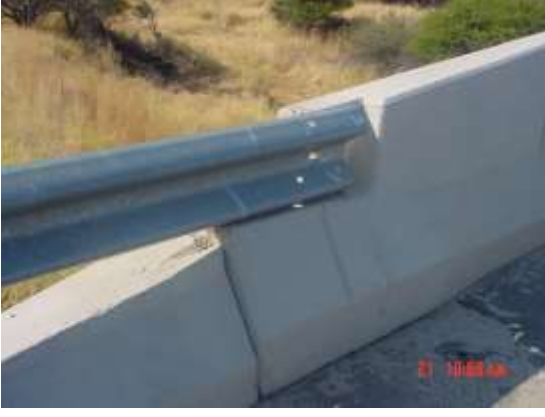
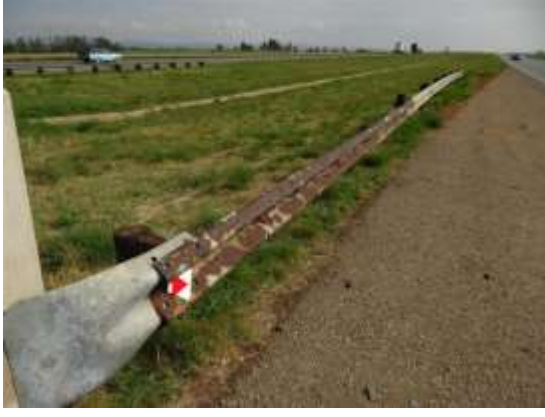
Left DER-U 212-3			
Right DER-U 222-3			
	Fix guardrail to end block	Fix to end block, corrosion and missing posts	
D = 3

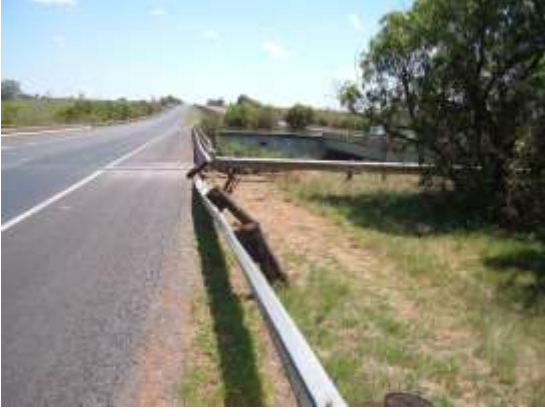
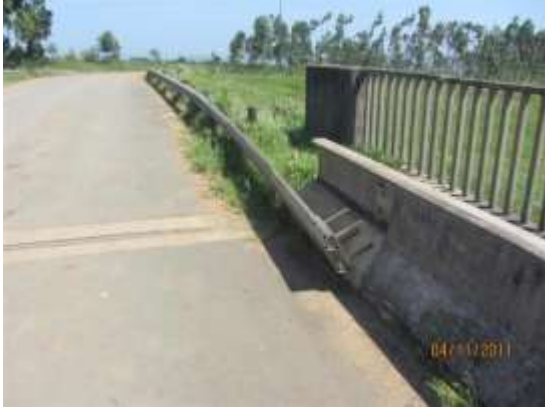
Left DER-U 313-3			
Right DER-U 313-3			
	Guardrail extensively damaged	Fix guardrail to NJ barrier	
D = 4

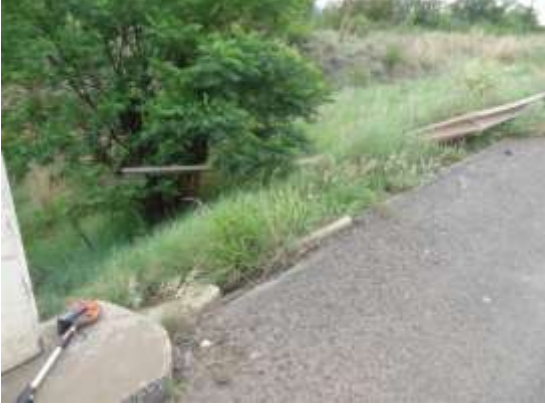
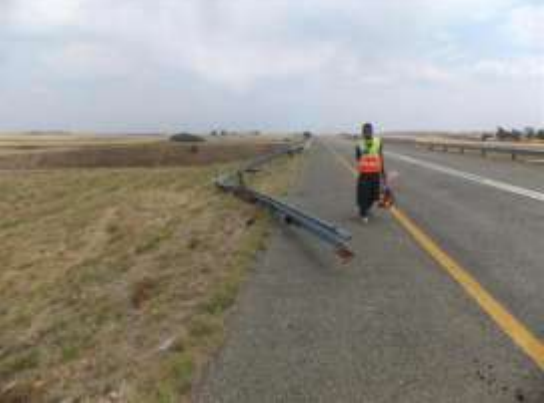
Left DER-U 413-3			
Right DER-U 414-4			
	Accident resulting in guardrail displacement	Guardrail protrusion into roadway (MS)

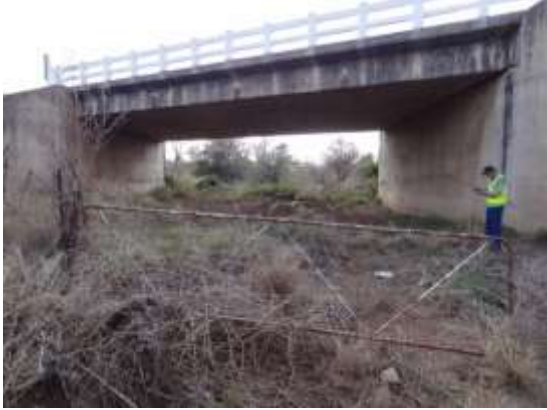
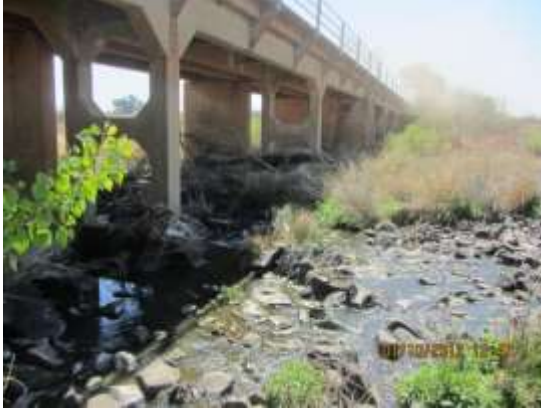
**Item 3 Waterway Defect Photos**

Left DER-U 111-2		
Right DER-U 111-2		
Vegetation and gate in waterway		Debris and vegetation in waterway
D = 2

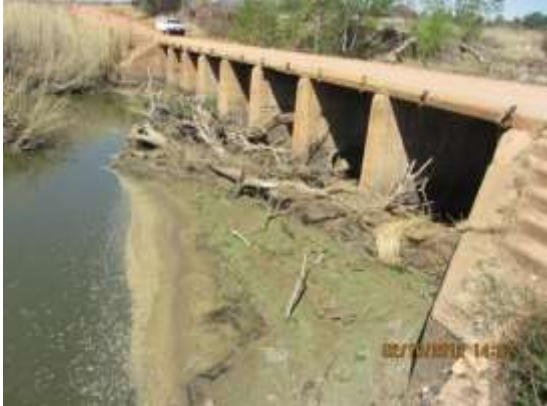
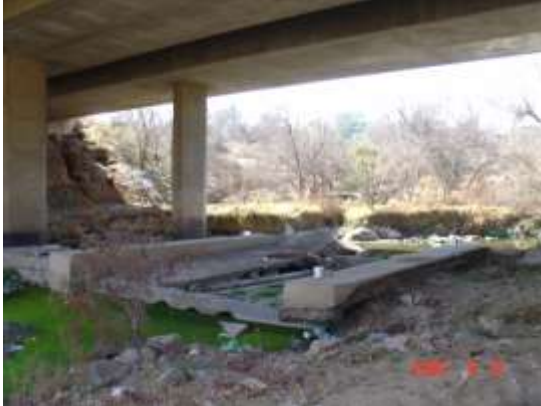
Left DER-U 232-2		
Right DER-U 222-2		
Inlets clogged by debris		Original scaffold founding blocking waterway
D = 3

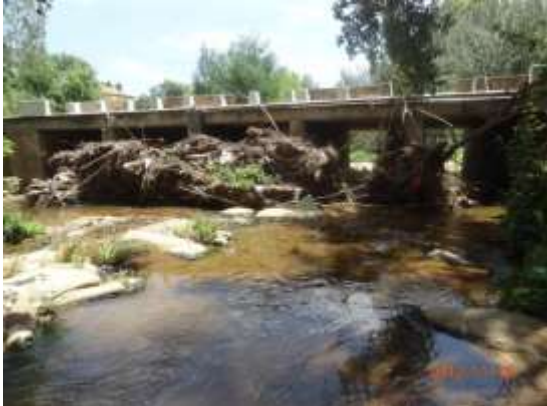
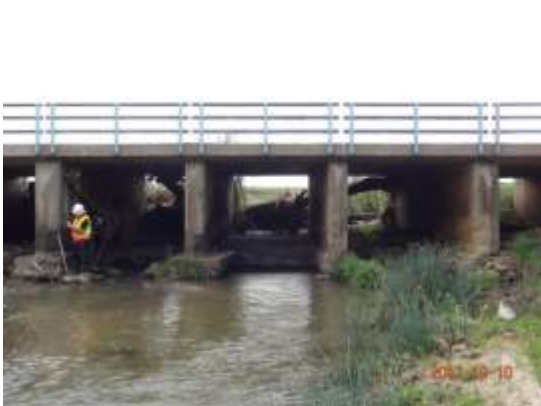
Left DER-U 333-3		
Right DER-U 333-3		
Inlets clogged by debris		Debris and tree blocking waterway
D = 4

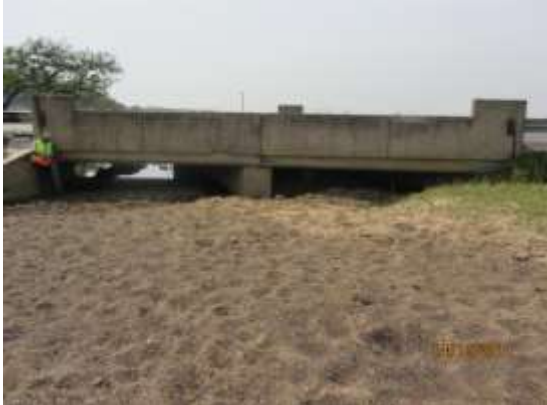
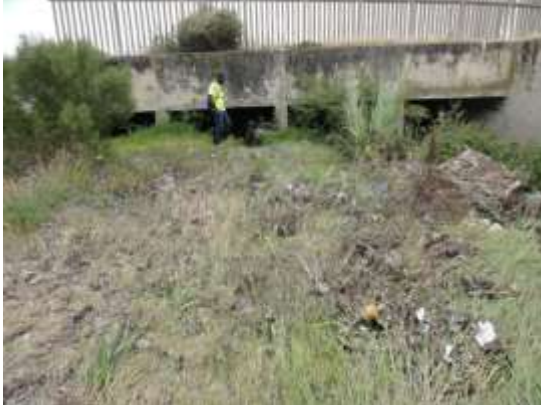
Left DER-U 443-4		
Right DER-U 432-3		
Siltation blocks waterway		River relocation

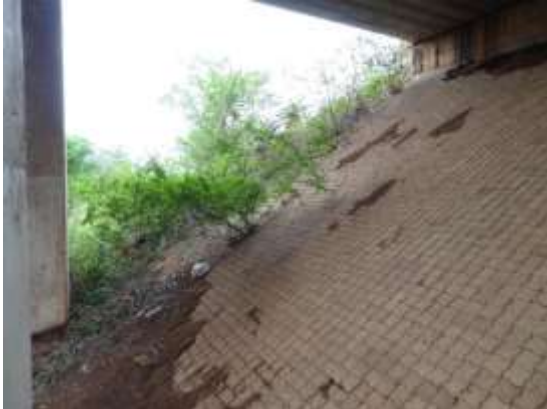
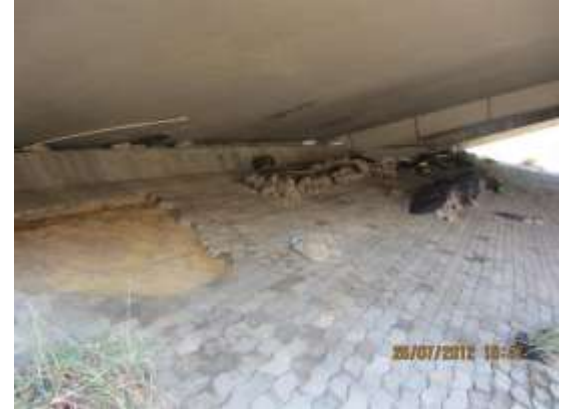
**Item 4 Approach Embankment Protection Works Photos**

Left DER-U 131-2		
Right DER-U 121-2		
Vegetation on embankment protection works		Interlocking blocks removed
D = 2

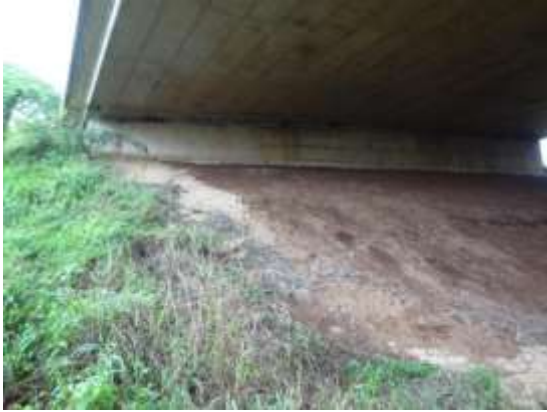
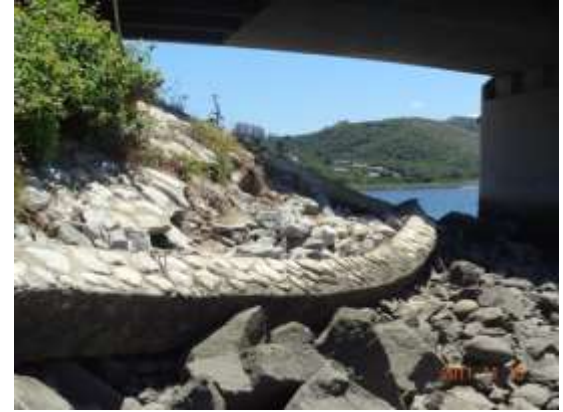
Left DER-U 242-2		
Right DER-U 232-2		
Embankment protection works taken away		Stone pitching damaged and under-soured
D = 3

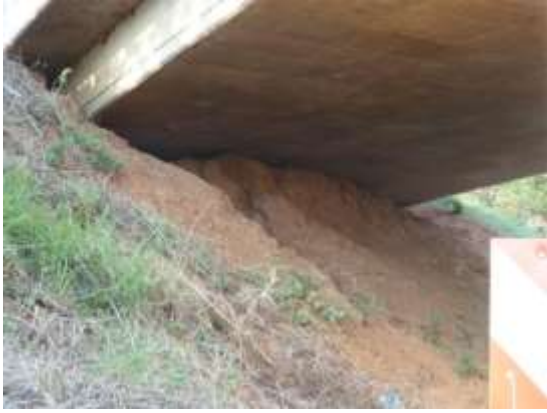
Left DER-U 333-3		
Right DER-U 332-2		
Embankment protection works not provided		Gabion mattress damaged and washed away
D = 4

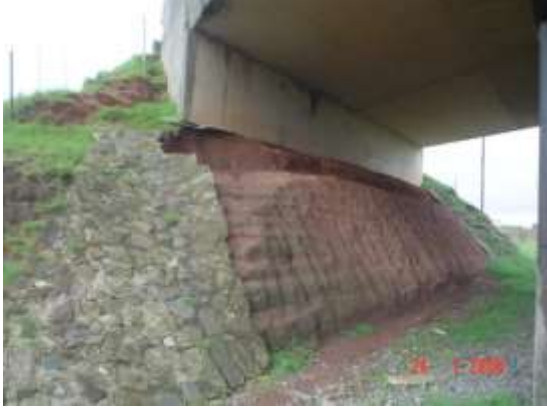
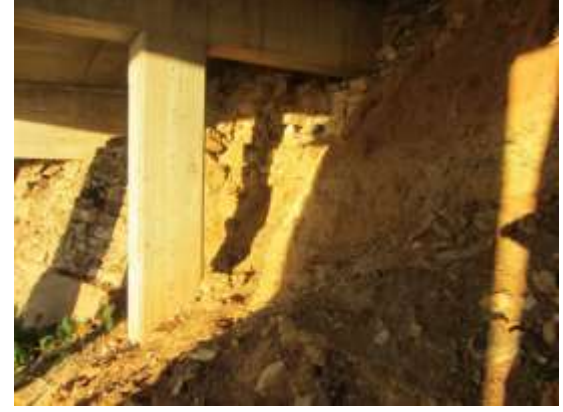
Left DER-U 433-3		
Right DER-U 443-3		
Embankment/slope protection works removed		Embankment protection works washed away

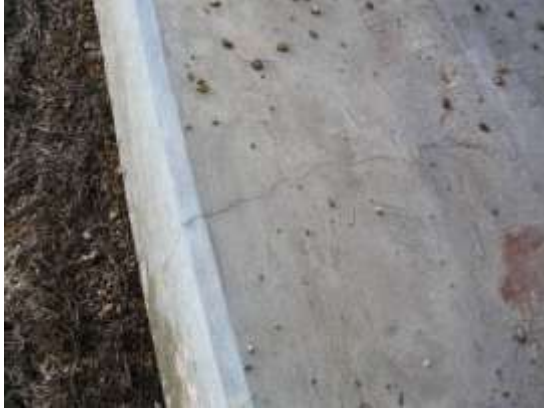
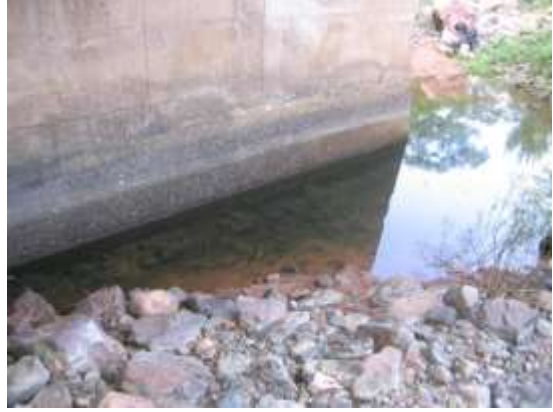
**Item 5 Abutment Foundation Defect Photos**

Left DER-U 111-2		
Right DER-U 131-2		
	Crack in abutment foundation	Local scour of foundation
D = 2

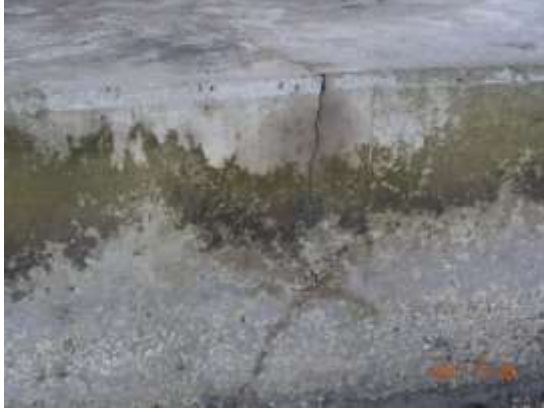
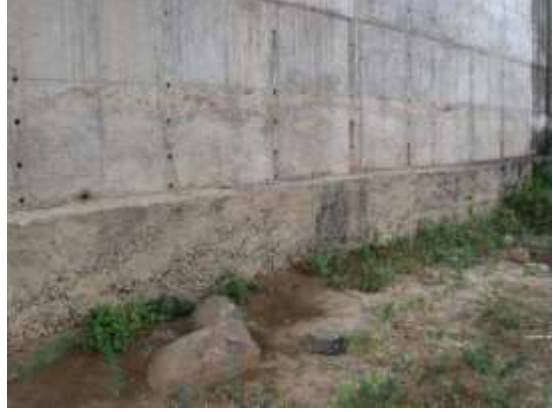
Left DER-U 212-2		
Right DER-U 231-2		
	Crack in abutment foundation	Honeycombing in foundation
D = 3

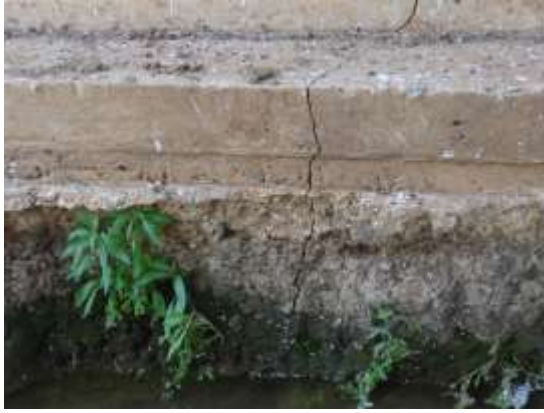
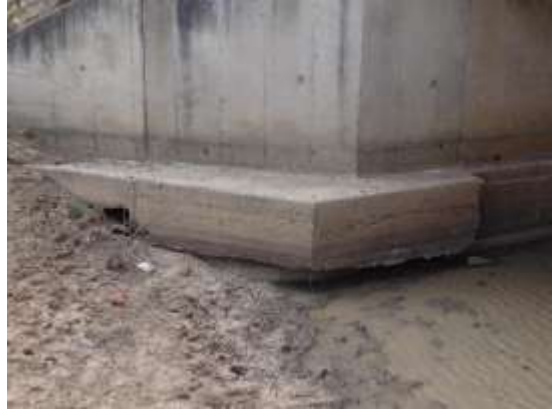
Left DER-U 323-4		
Right DER-U 332-3		
	Crack in abutment foundation	Scour of abutment foundation
D = 4

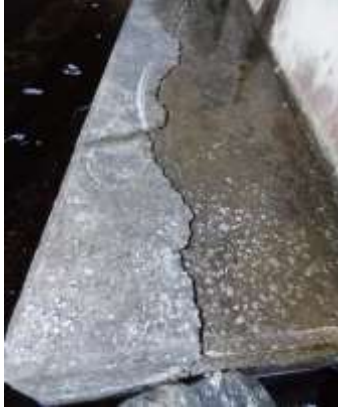
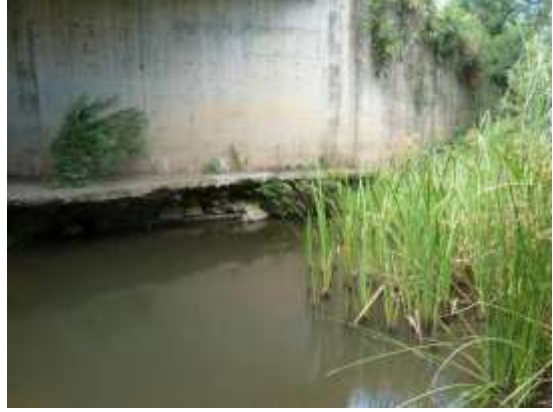
Left DER-U 443-3		
Right DER-U 433-3		
	Vertical crack in abutment foundation	Scour of abutment foundation

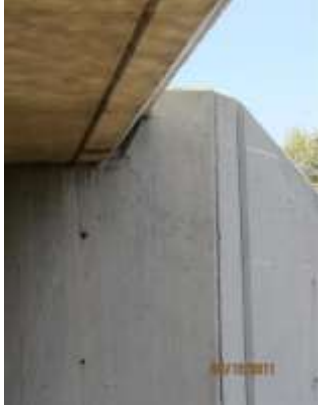
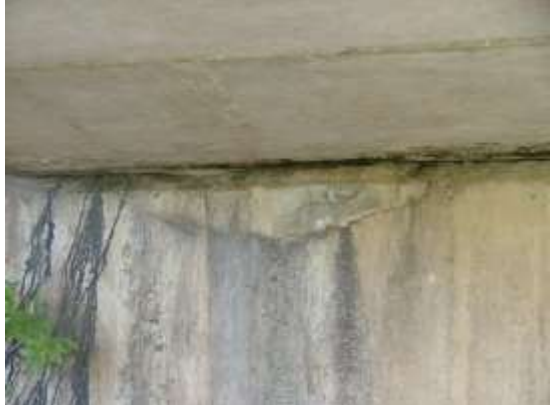
**Item 6 Abutment Defect Photos**

Left DER-U 111-2		
Right DER-U 111-2		
	Crack in abutment wall	Local spall in abutment wall
D = 2

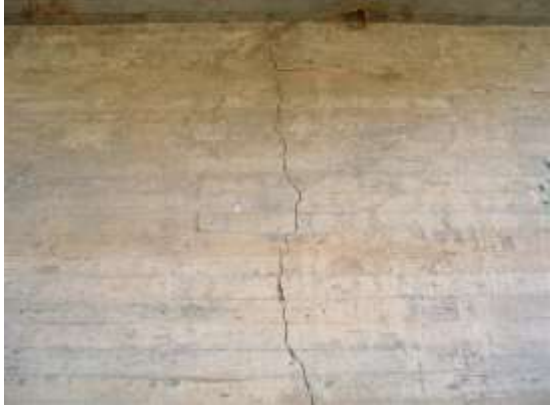
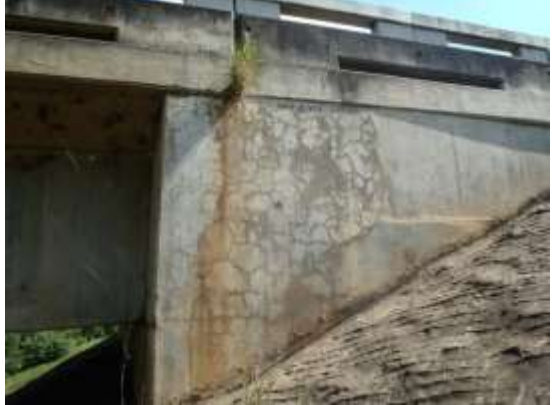
Left DER-U 211-2		
Right DER-U 222-3		
	Vertical crack in abutment wall	AAR cracking in return wall
D = 3

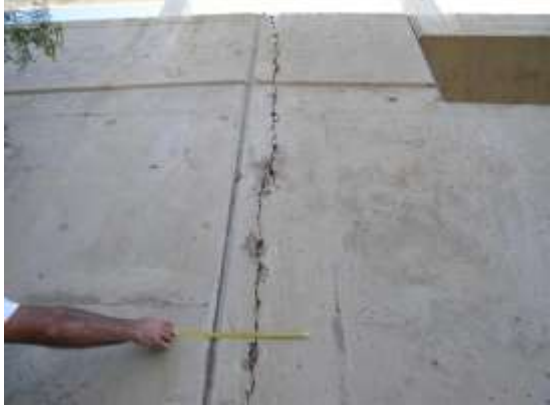
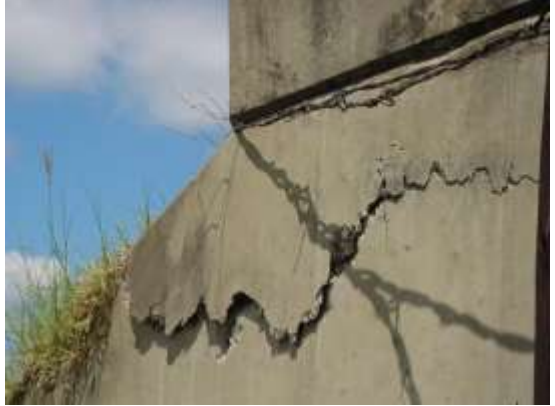
Left DER-U 311-2		
Right DER-U 312-3		
	Vertical crack in abutment return wall	Spalling at abutment return wall
D = 4

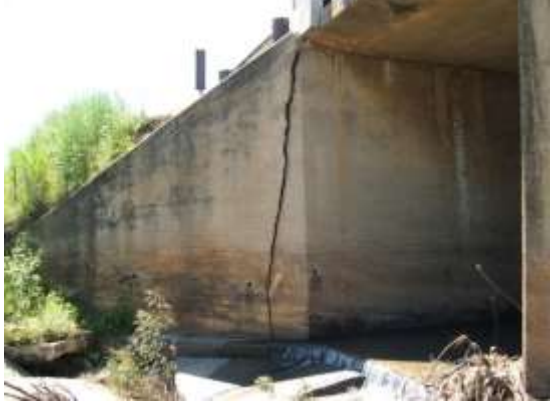
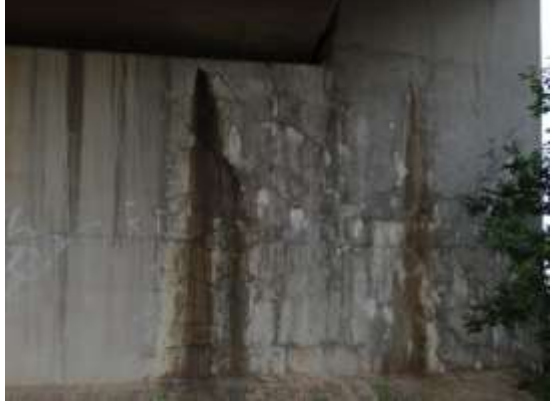
Left DER-U 413-3		
Right DER-U 433-3		
	Vertical crack in abutment wall	AAR in abutment wall

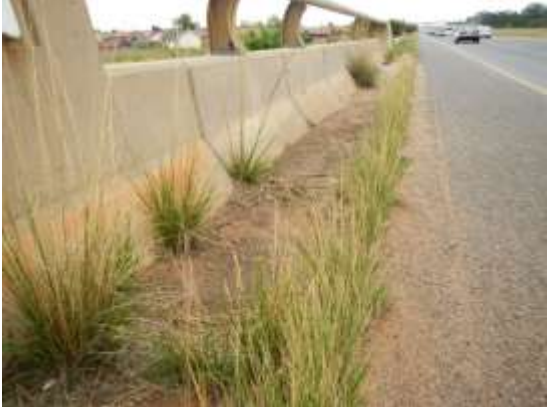
D = 1

Left DER-U 131-1		
Right DER-U 121-1		
	Gravel accumulated on deck	Vegetation growing on deck
D = 2

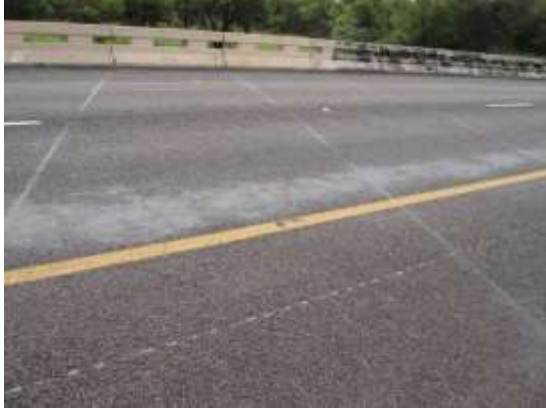
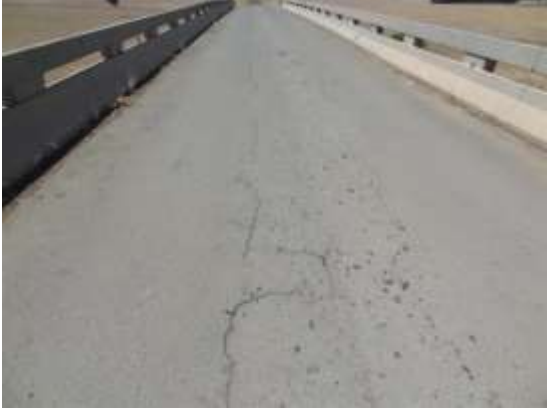
Left DER-U 222-2		
Right DER-U 232-2		
	Loss of skid resistance due to bleeding	Cracking of road surface
D = 3

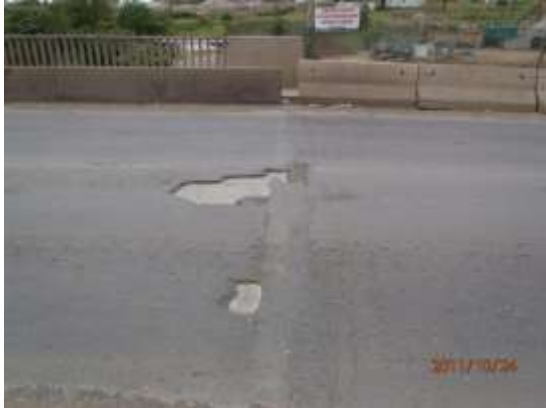
Left DER-U 322-3		
Right DER-U 323-3		
	Loss of surfacing on deck (potholes)	Large cracks and potholes in surfacing
D = 4

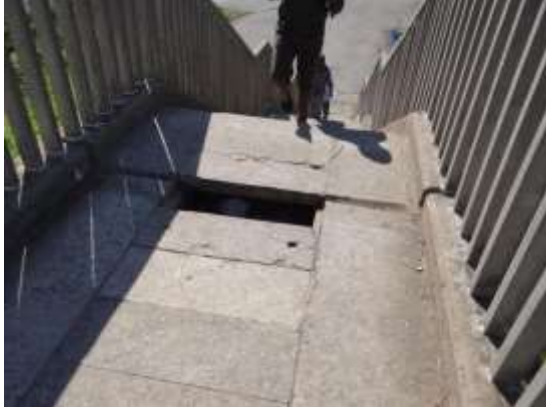
Left DER-U 414-4		
Right DER-U 423-3		
	Walkway surface panel missing (MS)	Severe cracks and potholes in surfacing

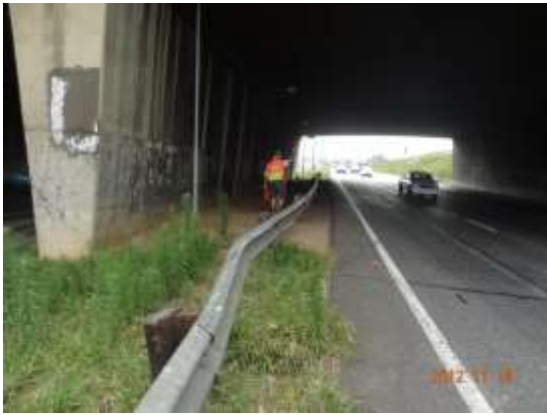
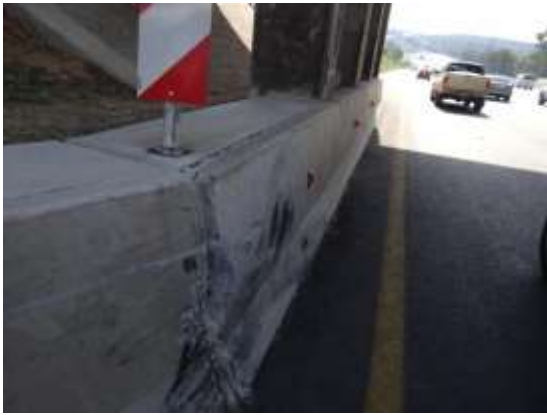
Item 12		Pier Protection Works Defect Photos	
D = 1

<p>Guardrail damaged</p> <p>Spall on pier protection</p>
Left DER-U 121-2			
Right DER-U 111-1			
D = 2

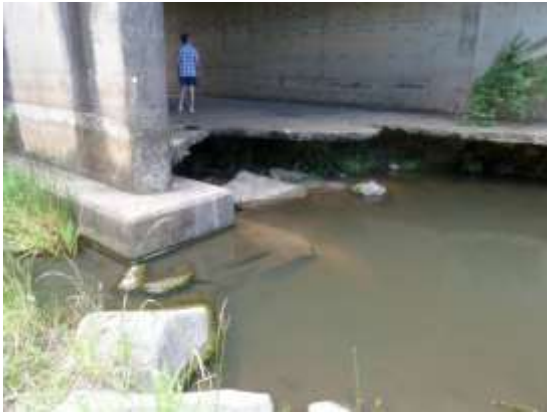
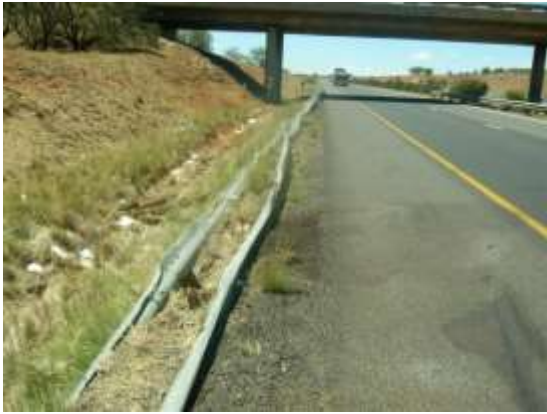
<p>Scour damage</p> <p>Accidental damage to guardrail</p>
Left DER-U 232-3			
Right DER-U 232-3			
D = 3

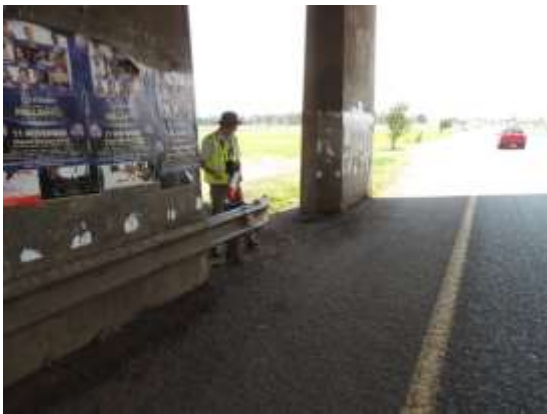
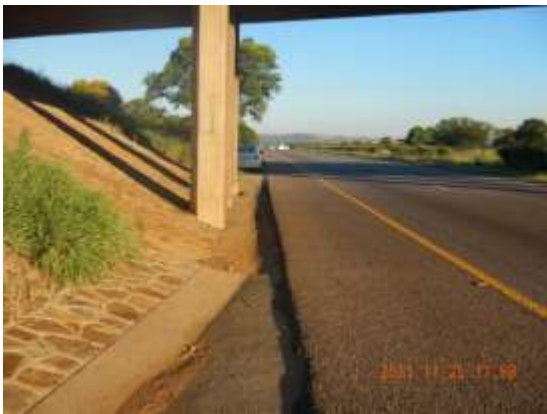
<p>Guardrail against and short of column</p> <p>Provide guardrail for pier protection</p>
Left DER-U 323-3			
Right DER-U 323-3			
D = 4

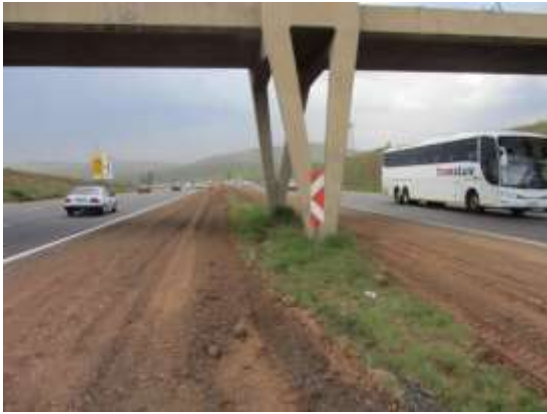
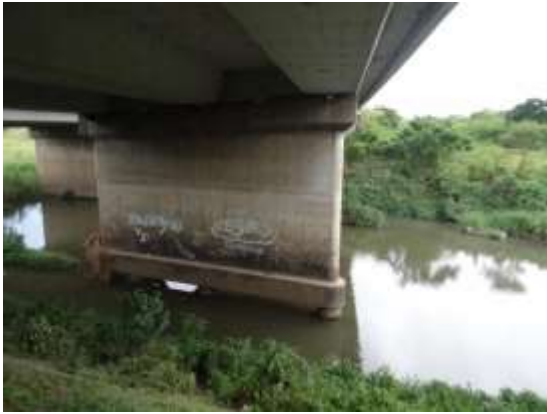
<p>Provide guardrail to protect slender pier</p> <p>Pier foundation piles exposed - protect</p>
Left DER-U 424-3			
Right DER-U 424-3

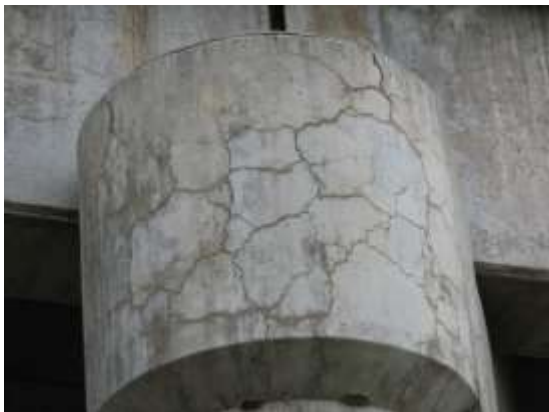
AAR cracking in pier head	Crack in pier nose
Left DER-U 321-3				
Right DER-U 312-3				
D = 4

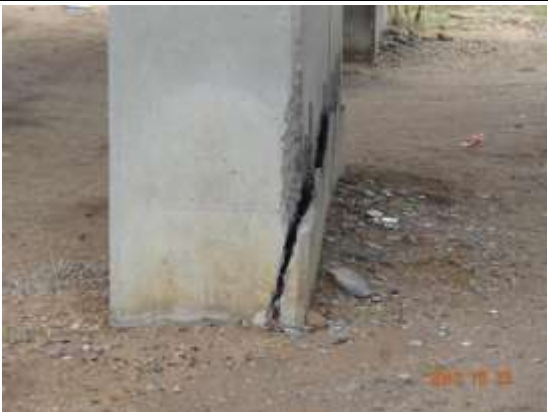
Spalling of pier nose	Spalling at column base
Left DER-U 413-4				
Right DER-U 413-4

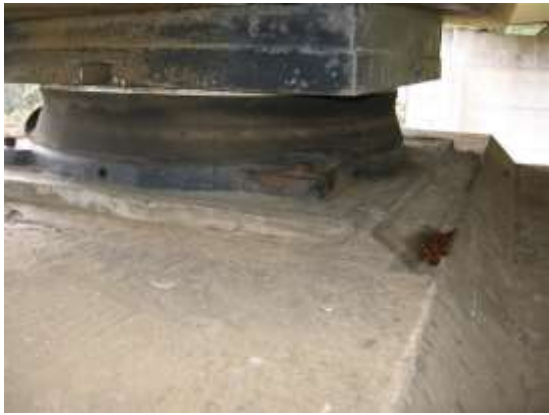
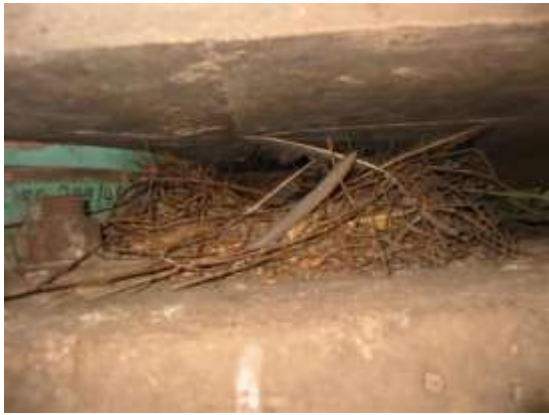
Item 15		Bearing Defect Photos	
D = 1

Left DER-U 111-0			
Right DER-U 111-1			
	Bearing lightly corroded	Bird's nest next to bearing	
D = 2	 	 	
Left DER-U 211-2			
Right DER-U 211-0			
	Debris causing corrosion	Elastomeric bearing cracking	
D = 3

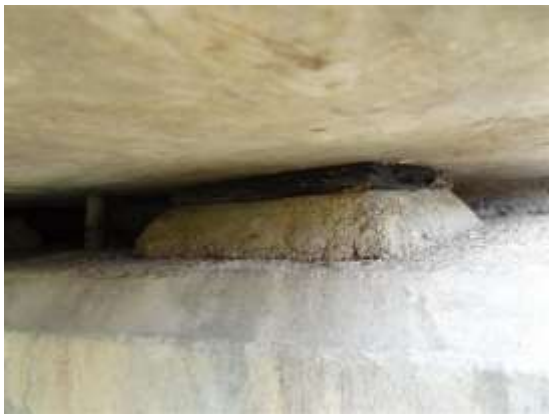
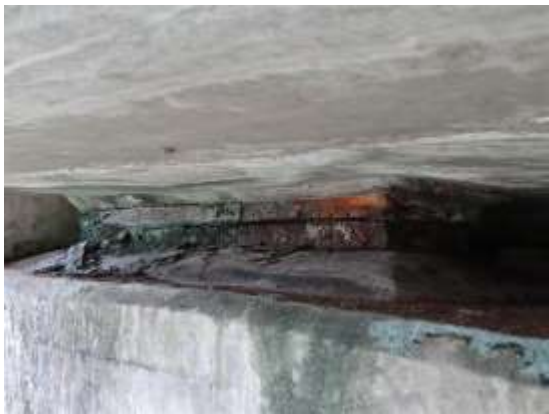
Left DER-U 312-2			
Right DER-U 332-2			
	Elastomeric bearing extensively cracked	Extensive corrosion and flaking	
D = 4

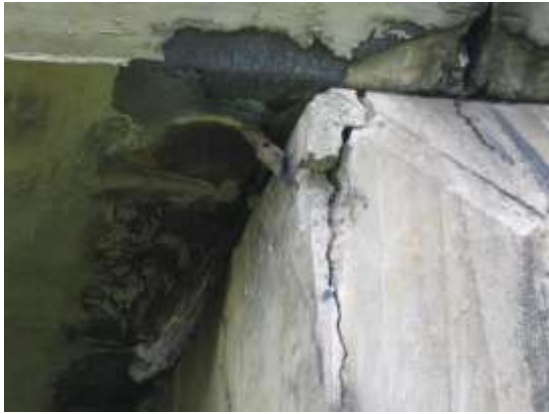
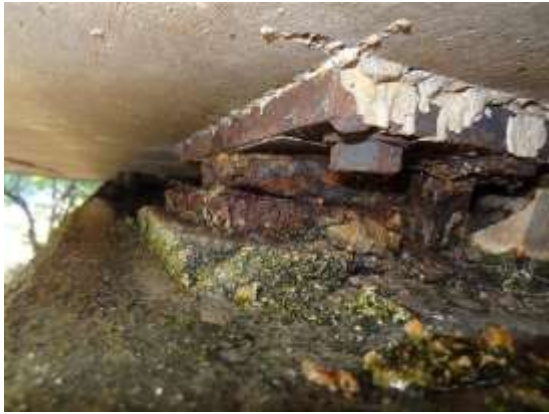
Left DER-U 424-4			
Right DER-U 433-3			
	Spalling due to bearing movement restraint	Corrosion has restrained movement

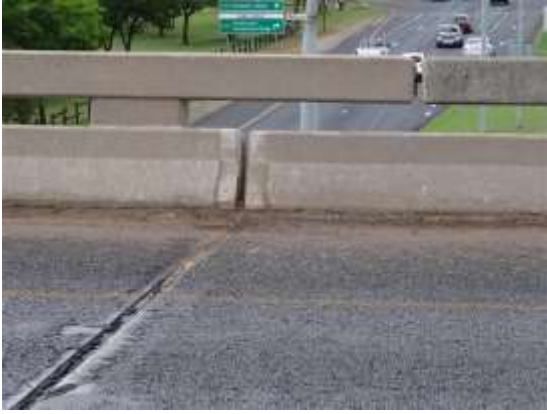
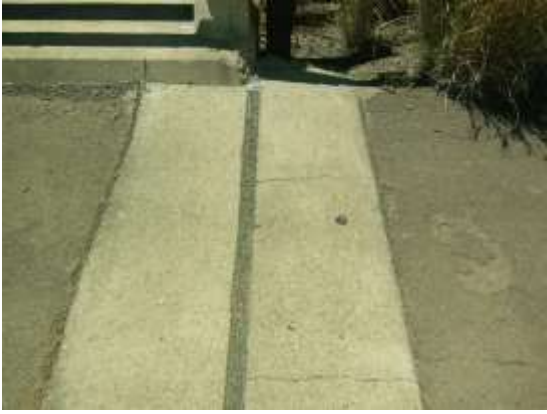
Item 17		Expansion Joint Defect Photos	
D = 1

Left DER-U 111-2			
Right DER-U 111-R			
	Parapet plate missing – small gap	Shrinkage cracks in nosing	
D = 2

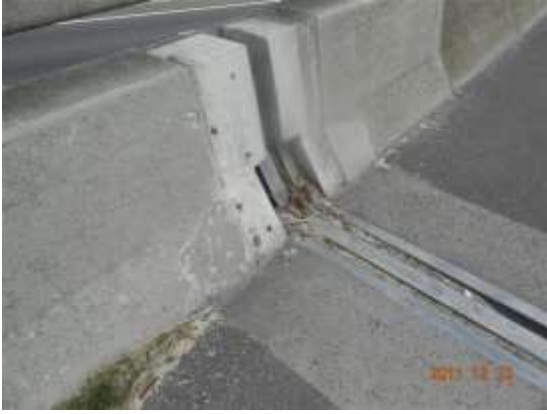
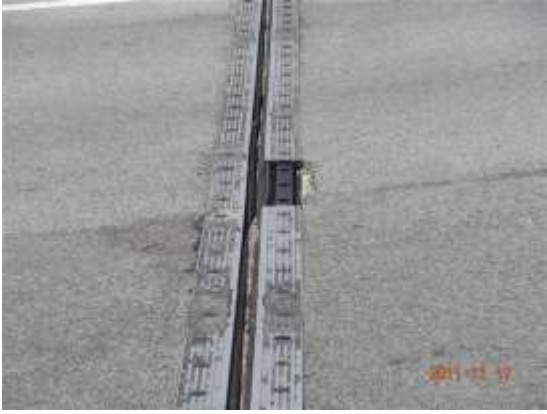
Left DER-U 211-2			
Right DER-U 211-2			
	Parapet plate missing – large gap	Part of bolt-down EJ has come off	
D = 3

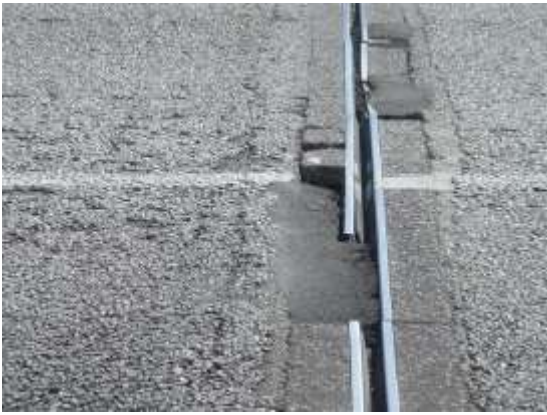
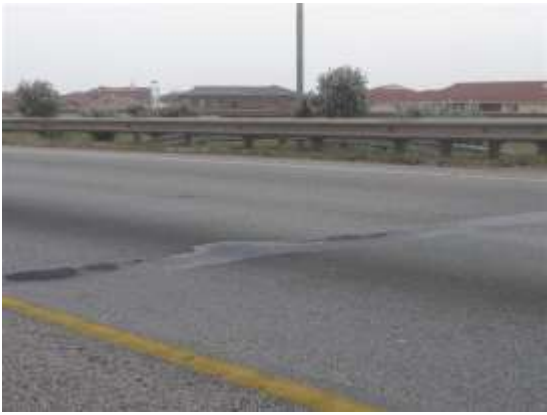
Left DER-U 323-3			
Right DER-U 332-3			
		Deep rutting	
D = 4

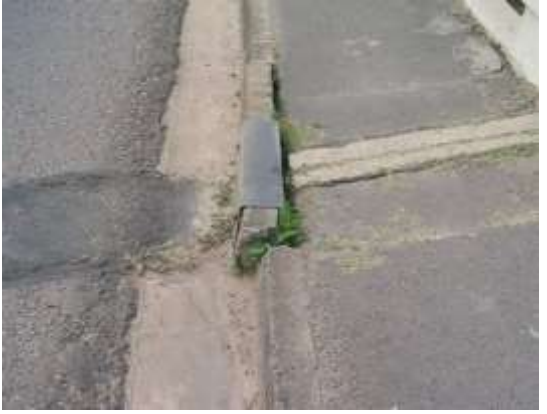
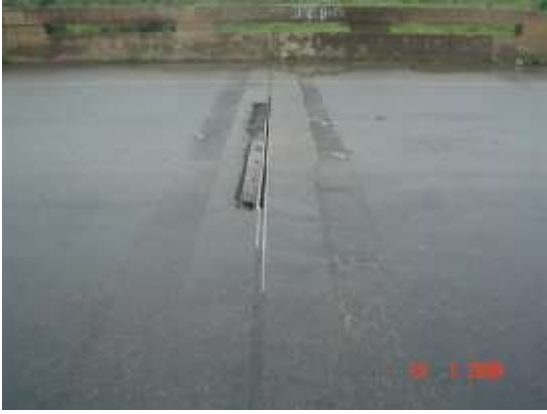
Left DER-U 424-4			
Right DER-U 424-4			
	Kerbstone loose – can cut tyre	Loose protruding plate in EJ

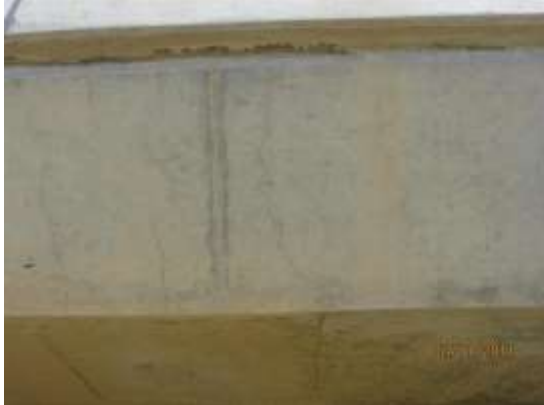
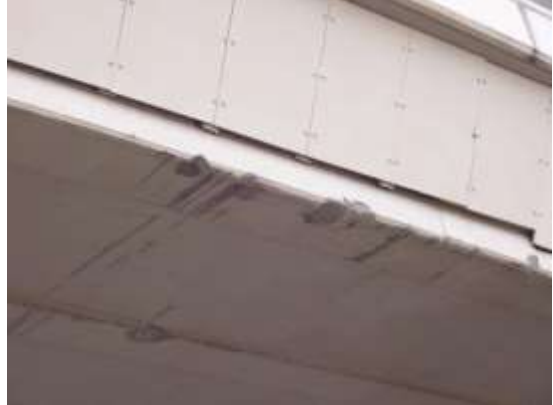
**Item 20: Deck & Slab Defect Photos**

Left DER-U 121-2		
Right DER-U 111-2		
	Vertical cracks in deck side	Collision spalling on deck edge
D = 2

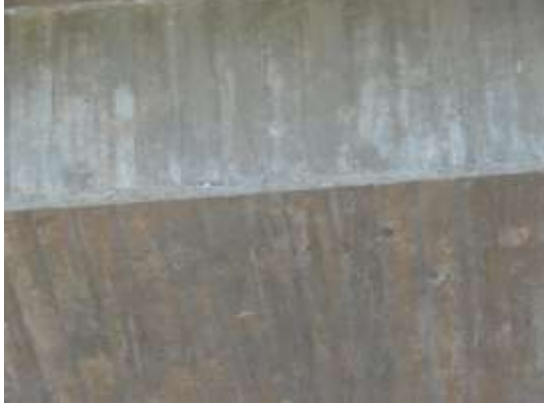
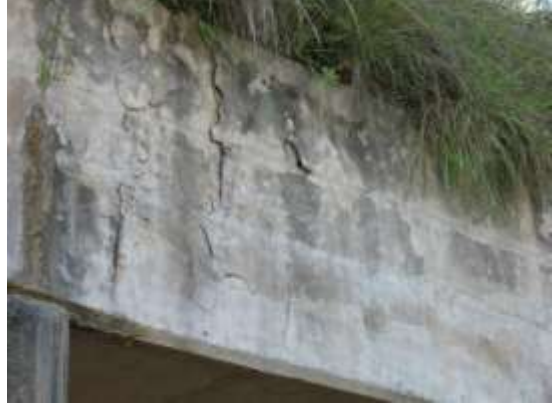
Left DER-U 221-2		
Right DER-U 212-2		
	Bending crack in deck	Spalling on deck due to lack of cover
D = 3

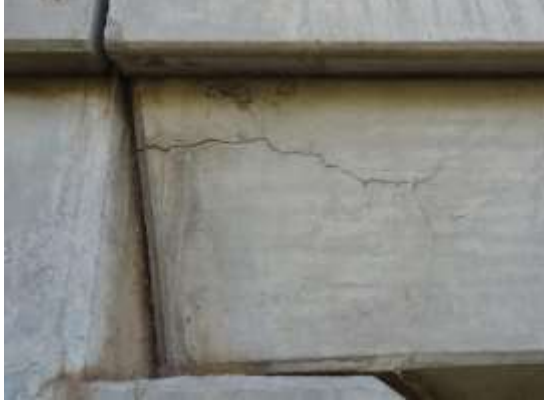
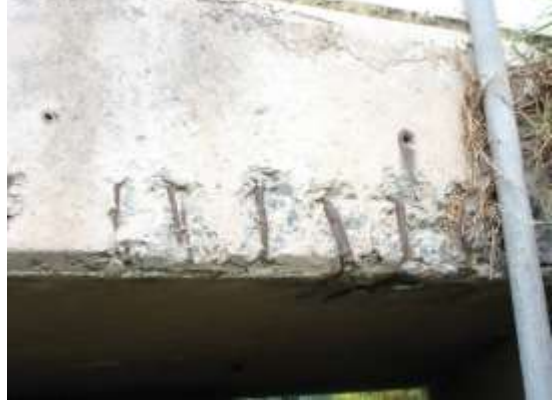
Left DER-U 312-3		
Right DER-U 322-3		
	Horizontal crack in deck	Spalling due to lack of cover
D = 4

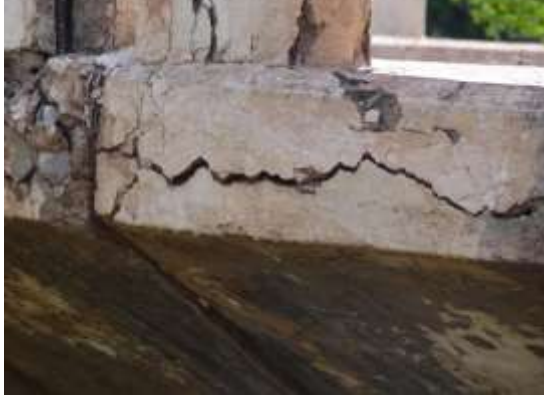
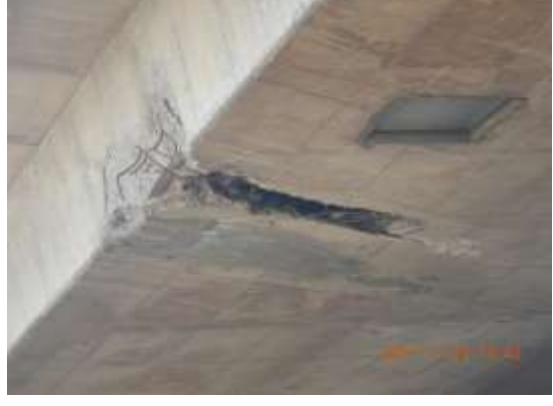
Left DER-U 422-3		
Right DER-U 413-4		
	Horizontal crack in deck edge	Collision spalling in box girder soffit

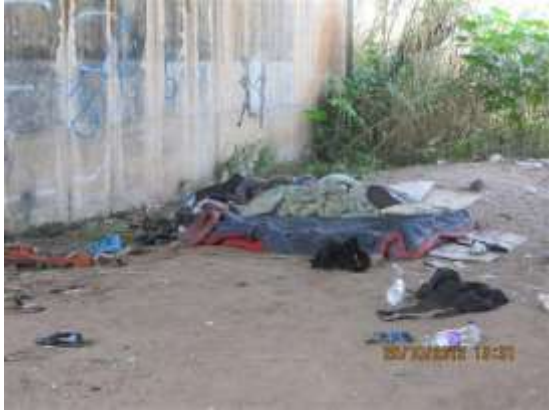
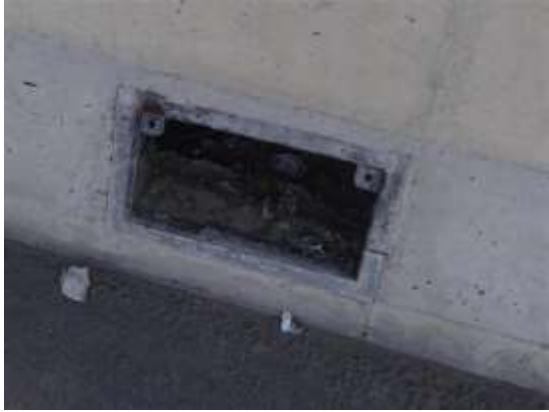
Item 21		Miscellaneous Items Defect Photos	
D = 1

Left DER-U 111-2			
Right DER-U 111-2			
	People living under bridge	Missing service duct cover – no services	
D = 2

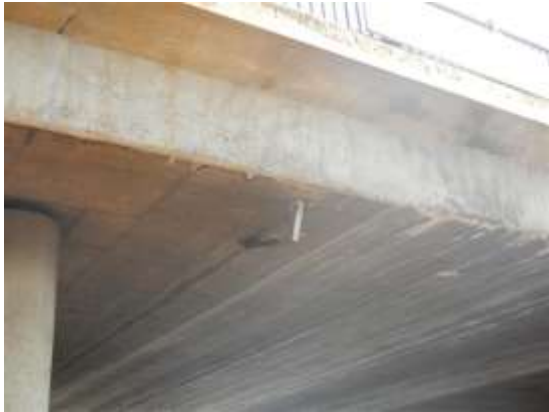
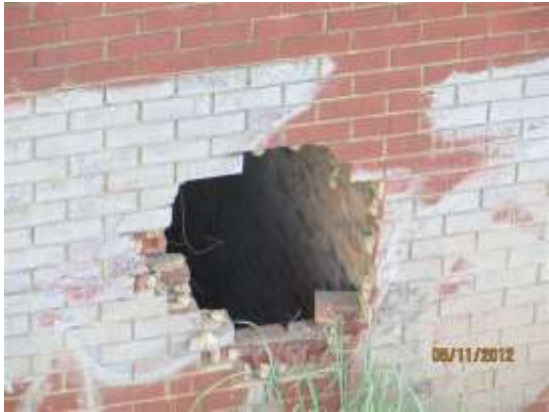
Left DER-U 212-2			
Right DER-U 212-3			
	Bridge with vertical clearance < 4.9 m	Hole in wall to gallery	
D = 3

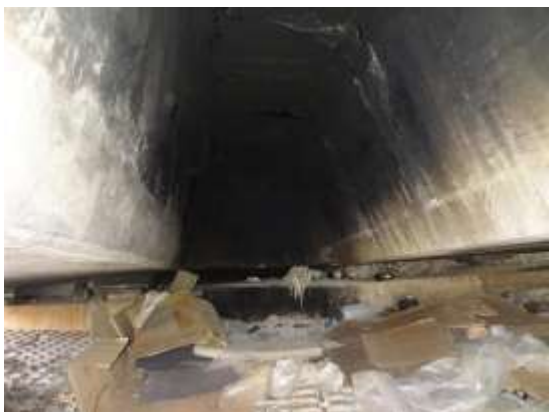
Left DER-U			
Right DER-U 313-4			
		People making fires under deck	
D = 4

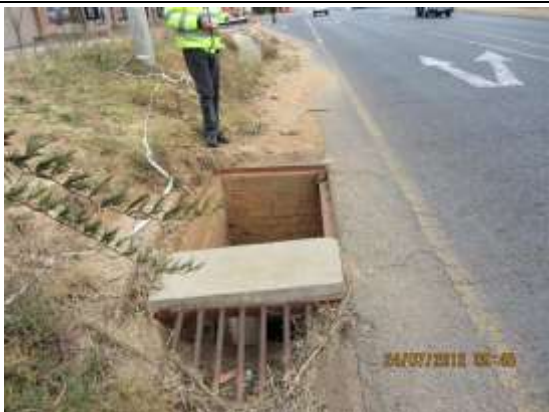
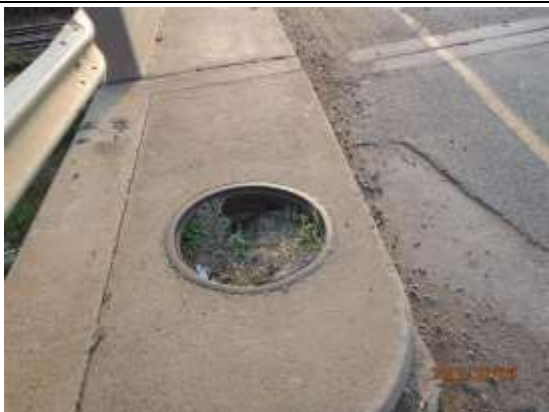
Left DER-U 413-4			
Right DER-U 414-4			
	Missing drainage cover next to road (MS)	Missing manhole cover on sidewalk (MS)

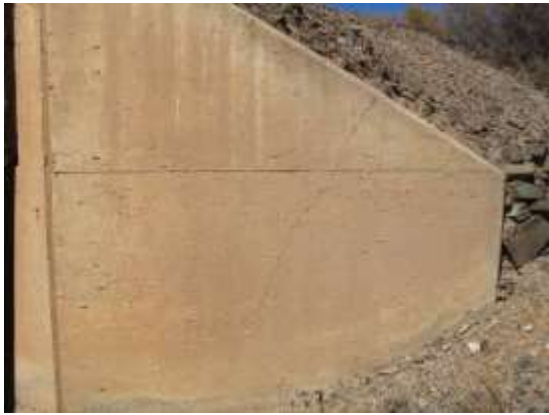
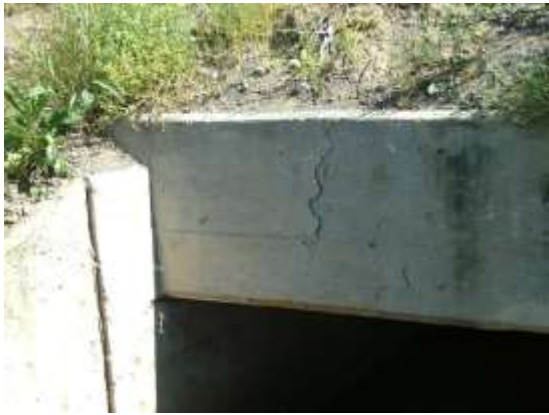
Item 2		Wing, Return, Head Wall Defect Photos	
D = 1

Left DER-U 111-2			
Right DER-U 111-2			
	Diagonal crack in wing wall	Spalling on head wall	
D = 2

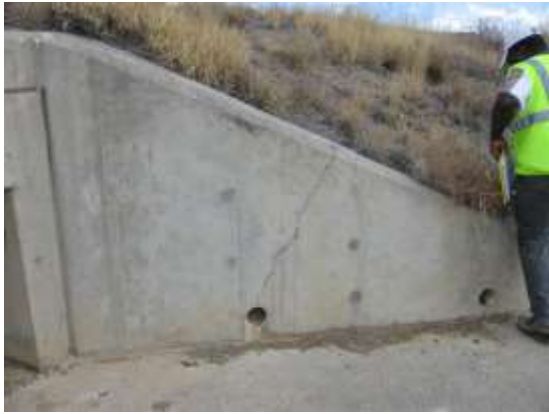
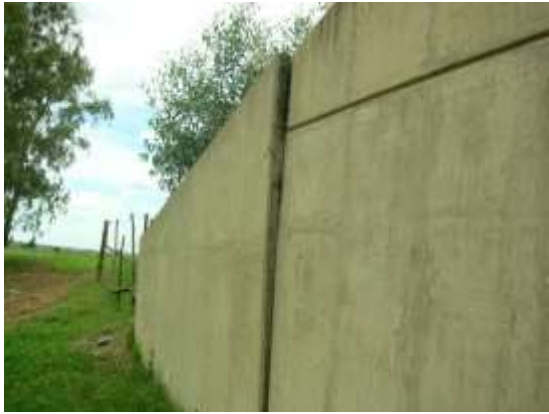
Left DER-U 212-2			
Right DER-U 222-2			
	Diagonal crack in wing wall	Wing wall leaning over	
D = 3

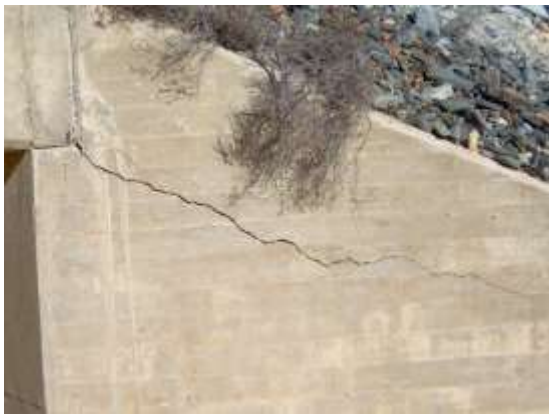
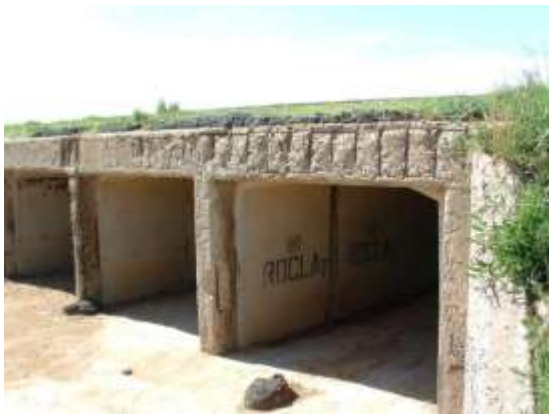
Left DER-U 322-2			
Right DER-U 333-3			
	Diagonal crack in wing wall	Spalling on head wall due to lack of cover	
D = 4

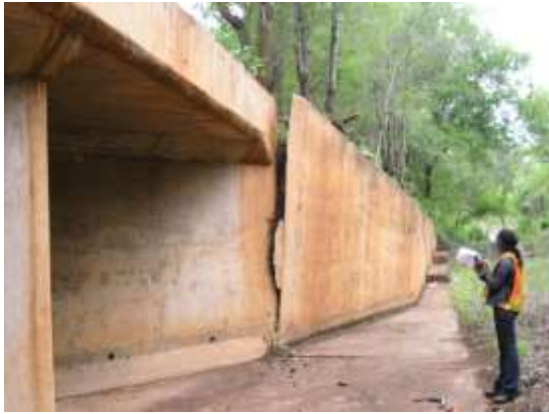
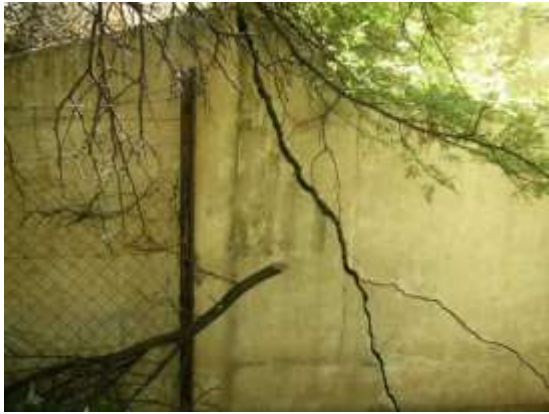
Left DER-U 414-4			
Right DER-U 434-4			
	Rotation of wing wall	Diagonal crack in wing wall

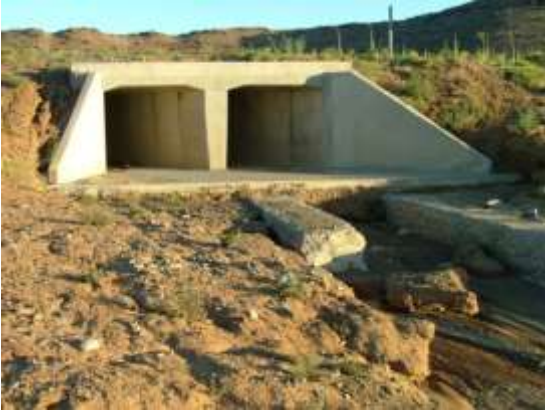
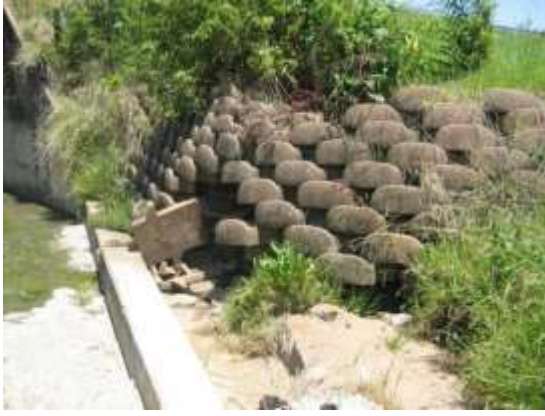
Item 3		Scour Protection Works (In Waterway) Defect Photos	
D = 1

Left DER-U 121-2			
Right DER-U 111-3			
	Embankment Erosion	Upstream precast concrete blocks broken	
D = 2
