**TMH19**

**MANUAL FOR THE VISUAL  
ASSESSMENT OF ROAD  
STRUCTURES**

**PART B: VISUAL ASSESSMENT GUIDE**

**August 2020**

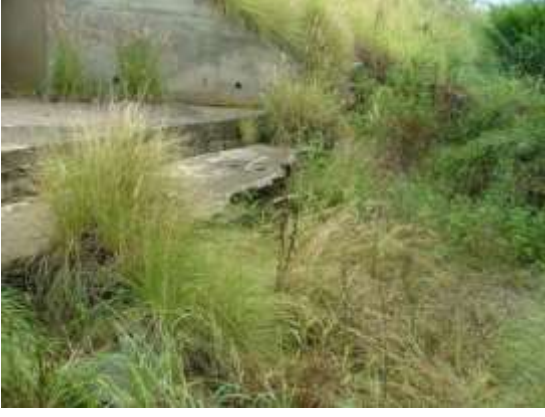
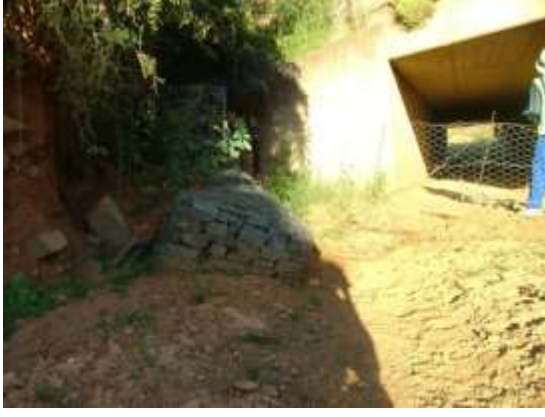
Left DER-U 221-2			
Right DER-U 222-2			
	Outlet scour under apron slab	Outlet scour shifting gabions	
D = 3

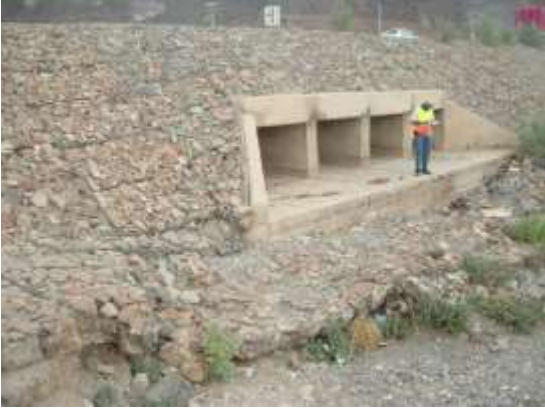
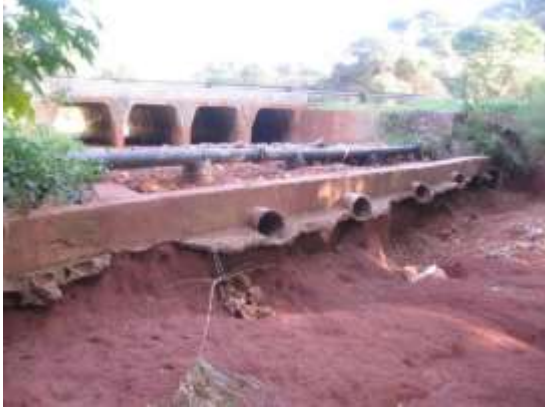
Left DER-U 332-2			
Right DER-U 331-1			
	Failed gabions at outlet	Erosion at outlet	
D = 4

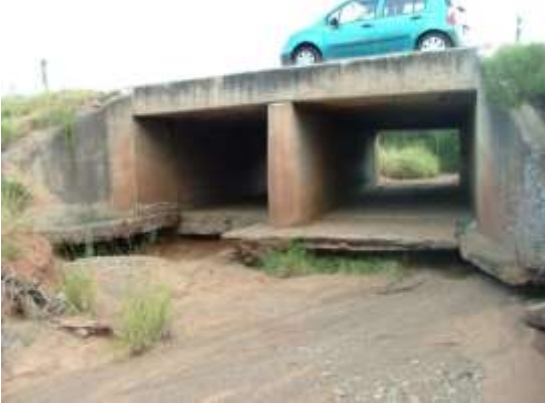
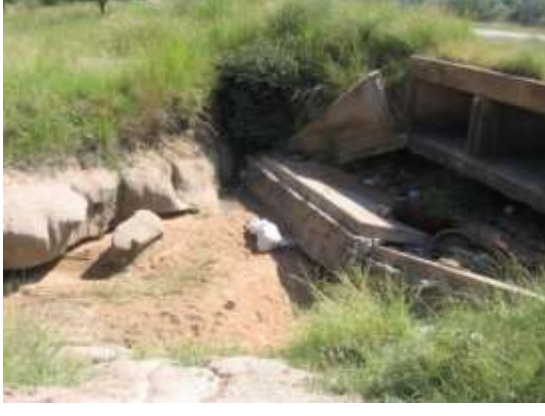
Left DER-U 433-4			
Right DER-U 433-4			
	Apron slab washed away	Apron slab severely damaged

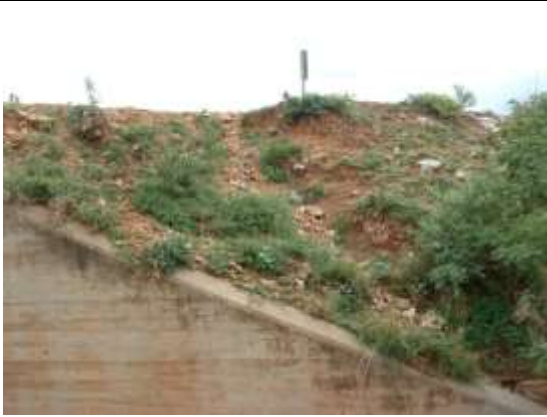
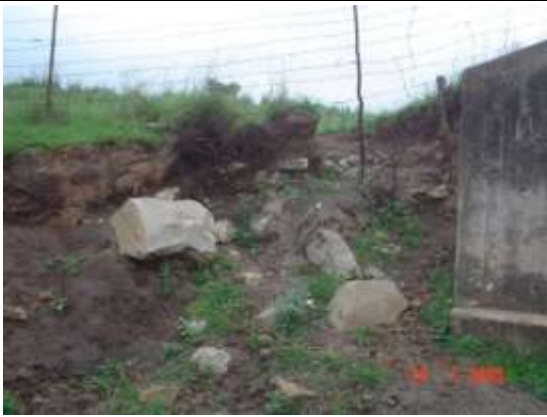
Item 4		Embankment Defect Photos	
D = 1

Left DER-U 121-2			
Right DER-U 121-2			
	Embankment Erosion	Erosion behind wing wall	
D = 2

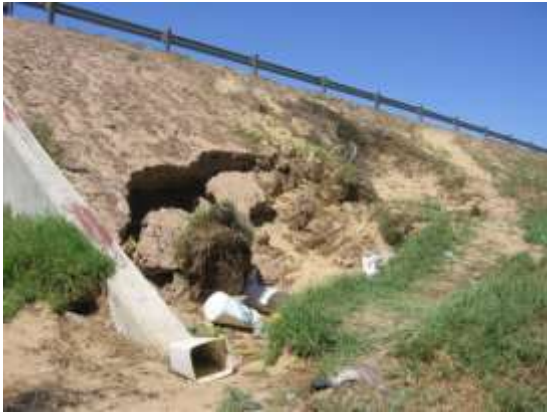
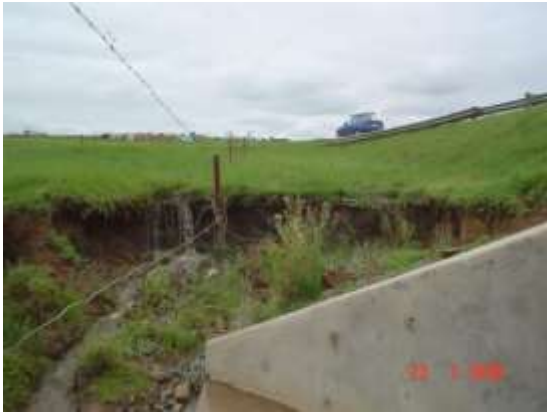
Left DER-U 221-2			
Right DER-U 222-2			
	Embankment Erosion	Erosion behind wing wall	
D = 3

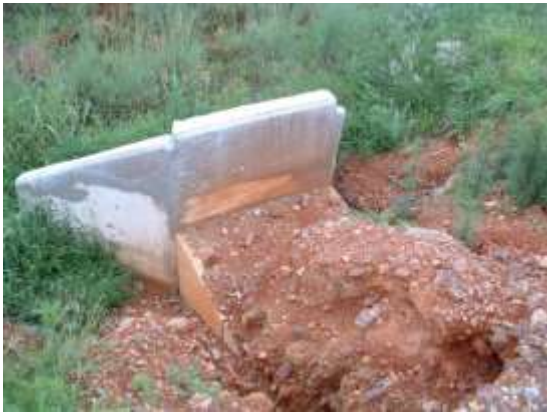
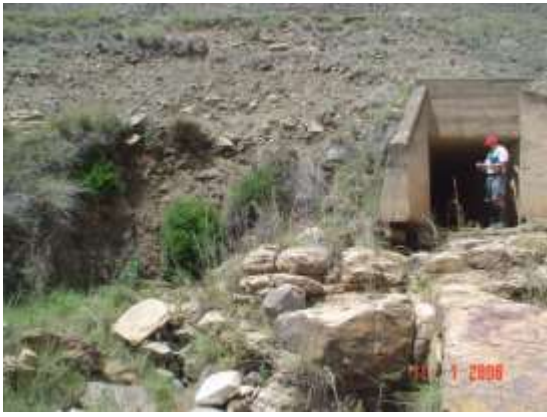
Left DER-U 323-3			
Right DER-U 311-2			
	Fill on culvert eroded away	Embankment Erosion	
D = 4

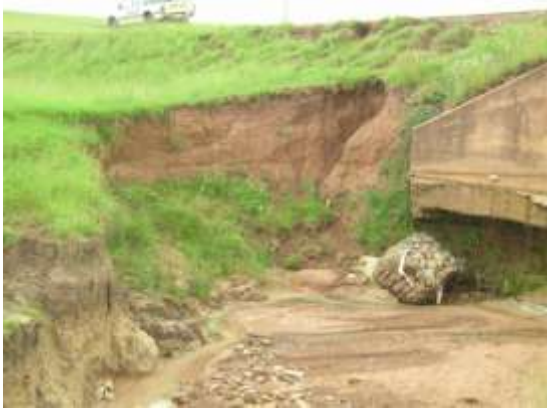
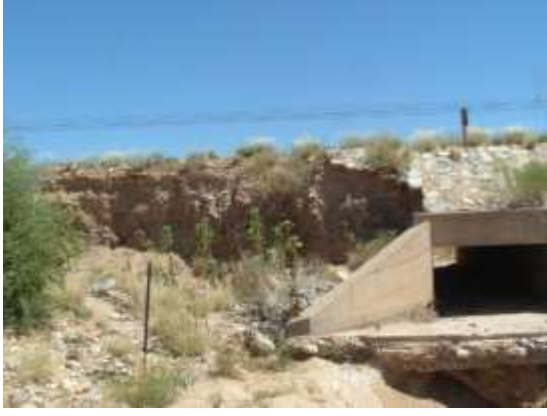
Left DER-U 422-3			
Right DER-U 433-4			
	Embankment Erosion	Existing stone pitching damaged through floods

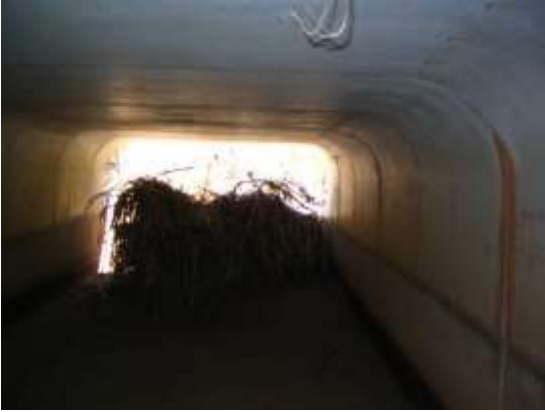
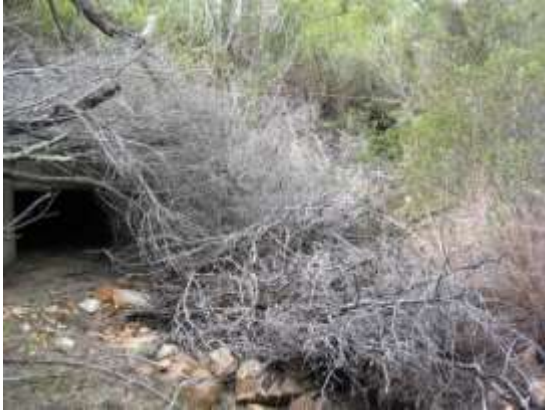
Item 5		Waterway Defect Photos	
D = 1

Waterway blocked
Left DER-U 111-2			
Right DER-U 121-2			
D = 2

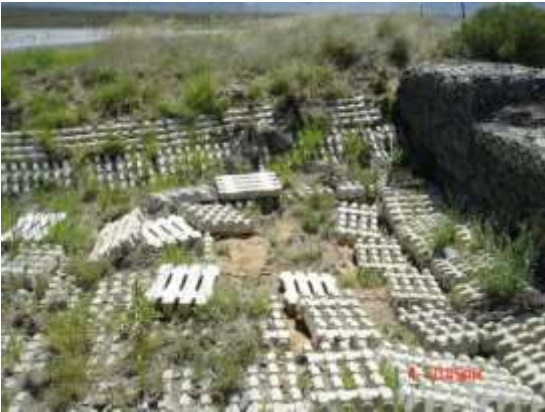
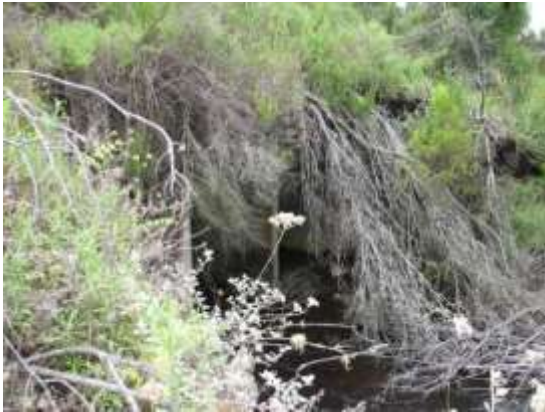
Waterway blocked
Left DER-U 232-3			
Right DER-U 222-3			
D = 3

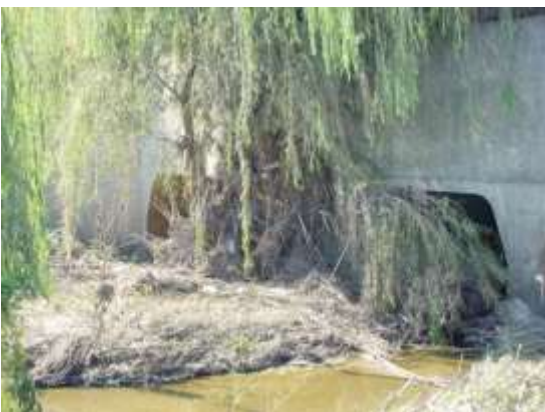
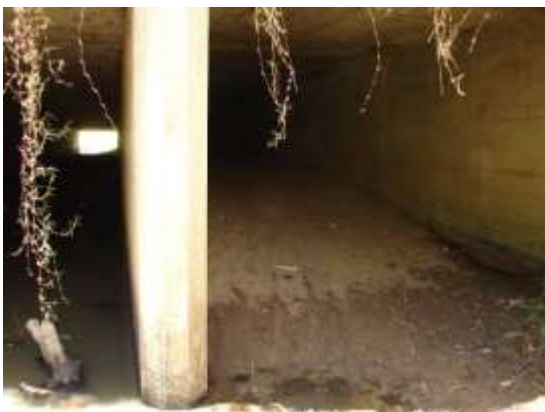
Culvert cell silted up
Left DER-U 323-3			
Right DER-U 322-3			
D = 4

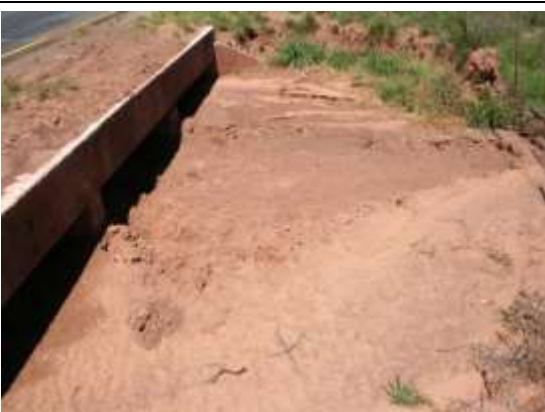
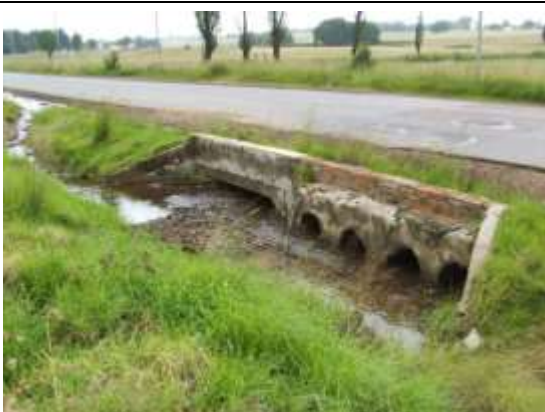
Culvert cells clogged with sand
Left DER-U 433-4			
Right DER-U 433-3			
	All culvert cells clogged with sand

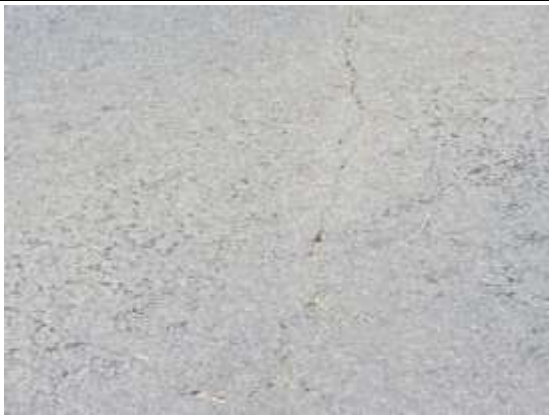
Item 6		Road Slab Defect Photos		
D = 1

Left DER-U 111-2				
Right DER-U				
	Crack in road slab			
D = 2

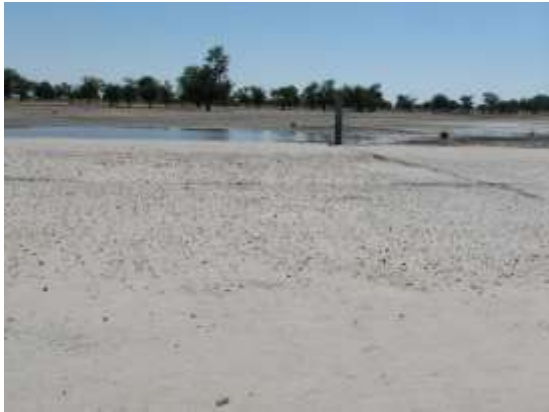
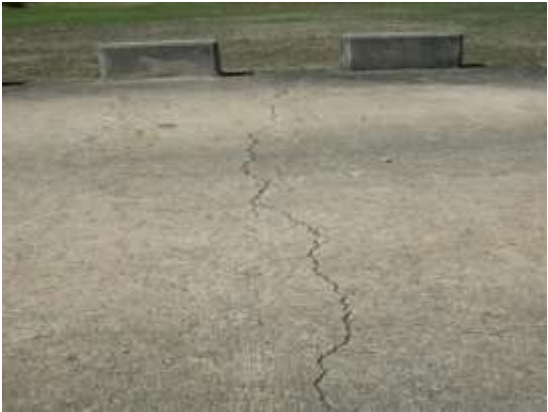
Left DER-U 222-2				
Right DER-U 222-2				
	Abrasion damage to road slab	Crack in road slab		
D = 3

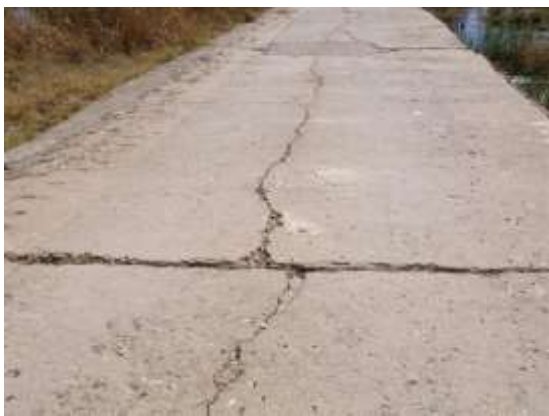
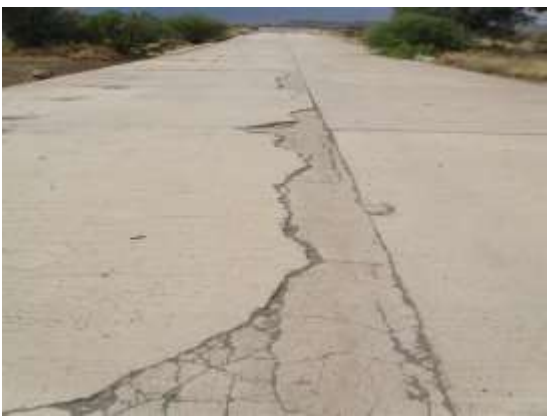
Left DER-U 332-3				
Right DER-U 322-3				
	Road slab cracking	Broken road slab		
D = 4

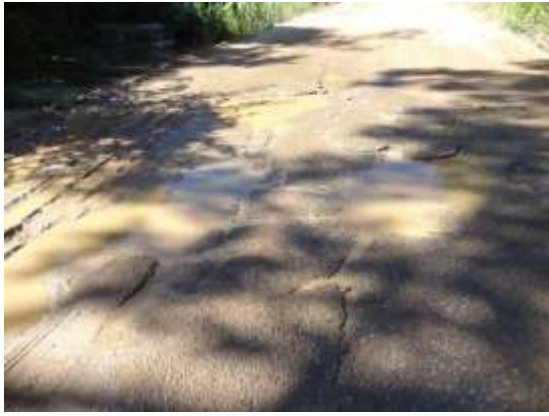
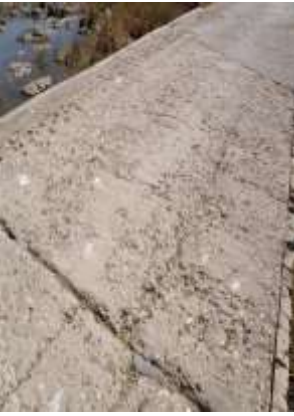
Left DER-U 433-4				
Right DER-U 442-3				
	Road slab breaking up	Road slab cracking

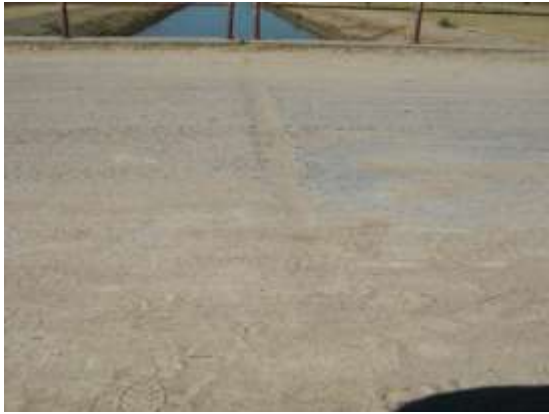
Item 7		Roadway Joint Defect Photos	
D = 1	 	 	
Left DER-U 121-2			
Right DER-U 121-1			
	Joint to be sealed	Grass in roadway joint	
D = 2

Left DER-U 212-2			
Right DER-U 343-1			
	Cracking at roadway joint	Joint filled with sand	
D = 3	 		
Left DER-U 332-3			
Right DER-U			
	Spalling at roadway joint		
D = 4	 		
Left DER-U 443-4			
Right DER-U			
	Spalling at joint

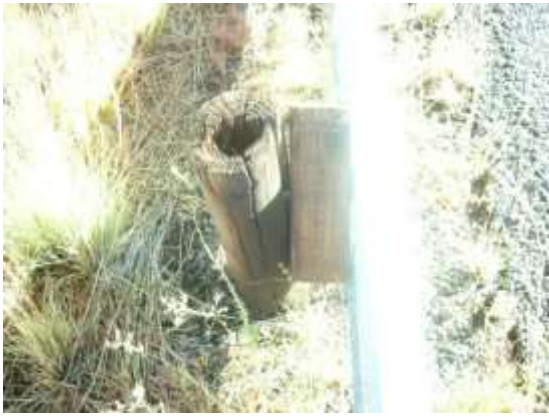
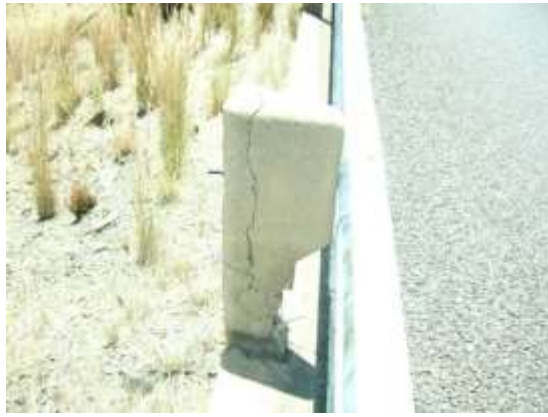
Left DER-U 111-2			
Right DER-U 111-2			
	Guardrail post rotten and weathered	Guardrail post cracked	
D = 2

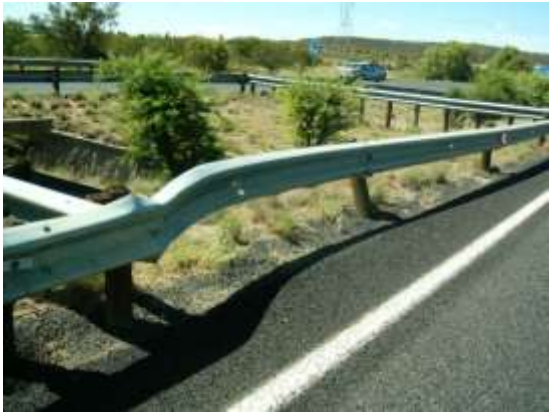
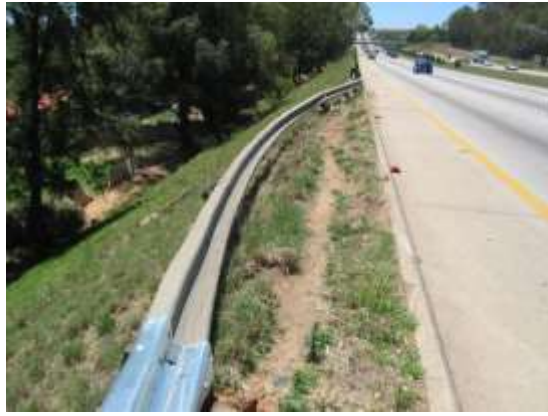
Left DER-U 211-3			
Right DER-U 222-3			
	Guardrail damaged by collision	Guardrail damaged by collision	
D = 3

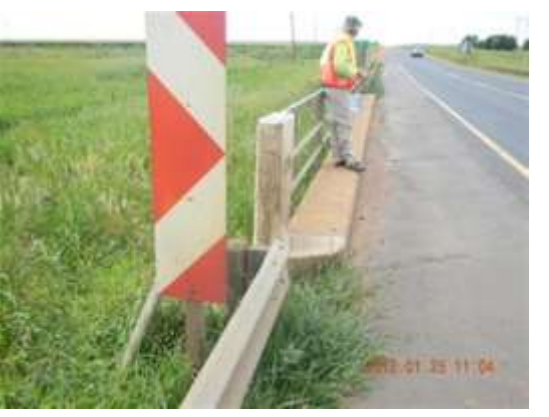
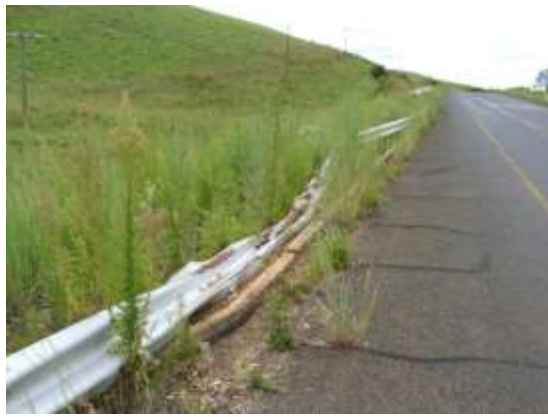
Left DER-U 313-3			
Right DER-U 322-3			
	Guardrail not attached to end block	Guardrail damaged by collision	
D = 4

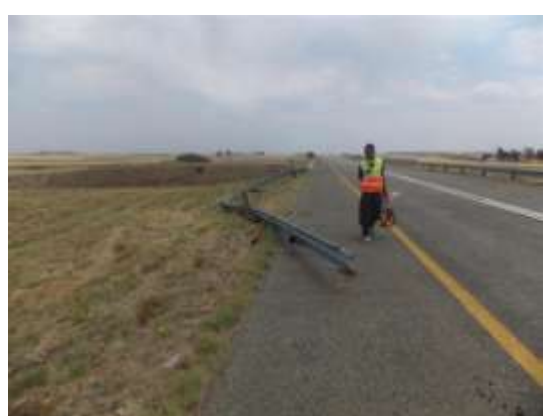
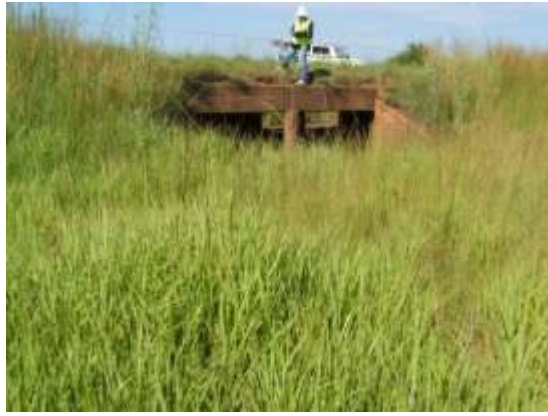
Left DER-U 423.4			
Right DER-U 442-3			
	Guardrail damaged by collision (MS)	No Guardrails

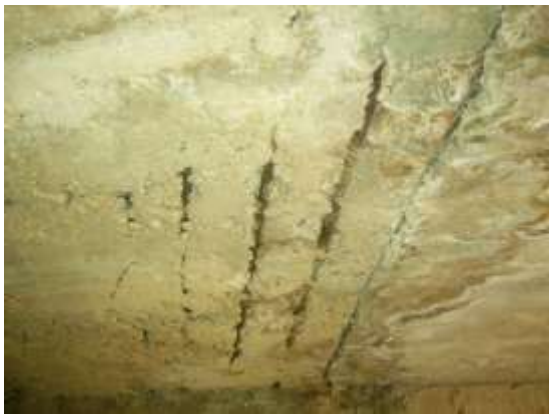
Item 11		Top Slab Defect Photos	
D = 1	 	 	
Left DER-U 111-1			
Right DER-U 111-1			
	Marginal honeycombing in slab	Minor spalling due to collision damage	
D = 2	 	 	
Left DER-U 222-2			
Right DER-U 212-2			
	Moderate honeycombing in slab	Moderate spalling due to restraint at joint	
D = 3

Left DER-U 323-3			
Right DER-U 323-3			
	Significant honeycombing	Significant spalling due to lack of cover	
D = 4	 	 	
Left DER-U 414-4			
Right DER-U 424-4			
	Severe shear cracks due to collision damage	Severe corrosion due to honeycombing

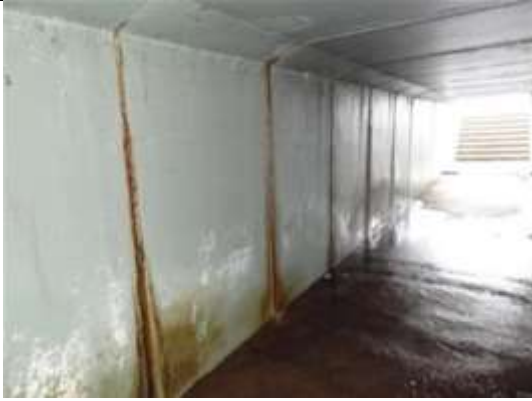
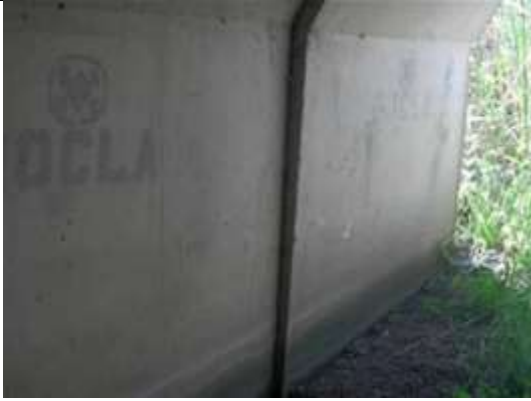
<p>Displacement of cell and leaking joints</p> <p>Displacement of cell (probably during construction)</p>
Left DER-U 122-2			
Right DER-U 111-2			
D = 2

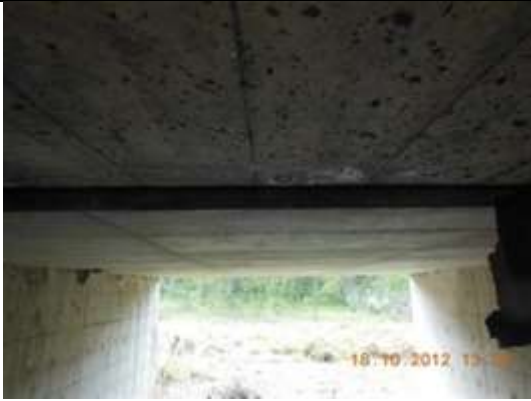
<p>Deformed Armco pipe</p> <p>Displaced top slab</p>
Left DER-U 242-3			
Right DER-U 222-3			
D = 3

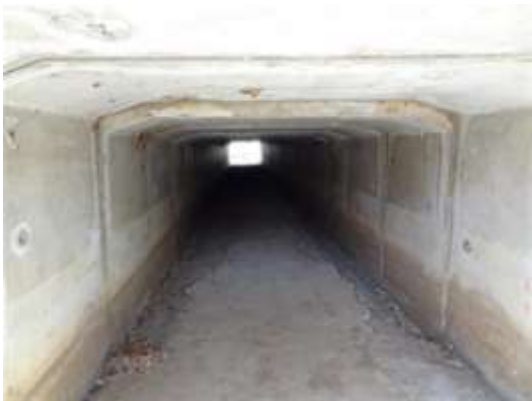
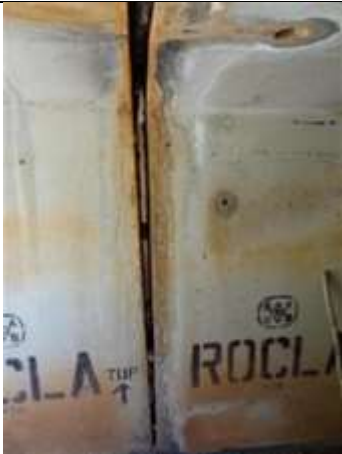
<p>Settlement of cells</p> <p>Settlement of cells</p>
Left DER-U 332-2			
Right DER-U 323-3			
D = 4

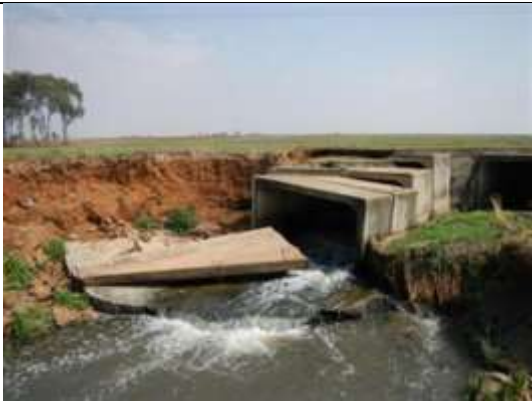
<p>Displacement of cells due to erosion</p>
Left DER-U 434-4			
Right DER-U

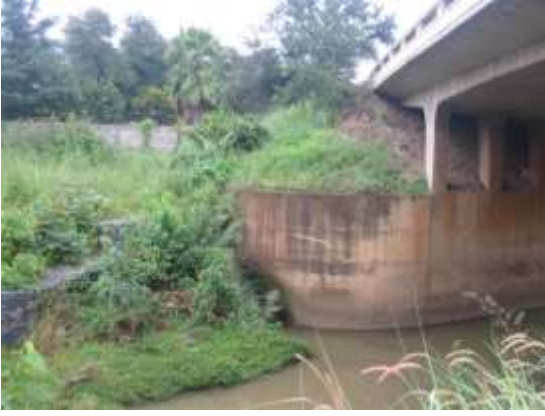
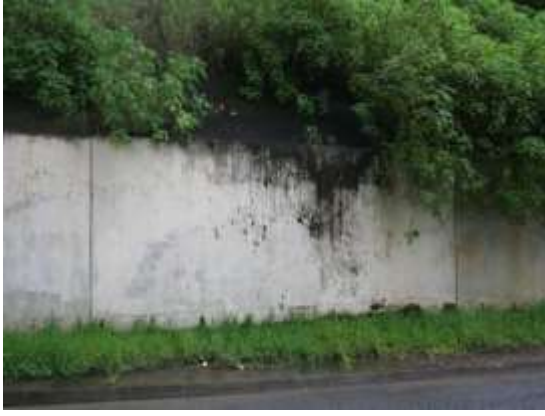
Left DER-U 121-2			
Right DER-U 111-2			
	Storm water runs over wall	Wall is stained	
D = 2

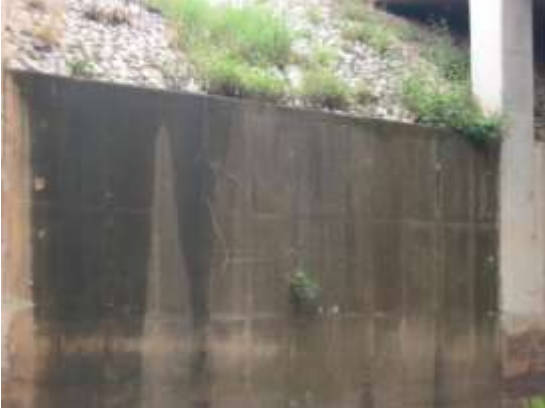
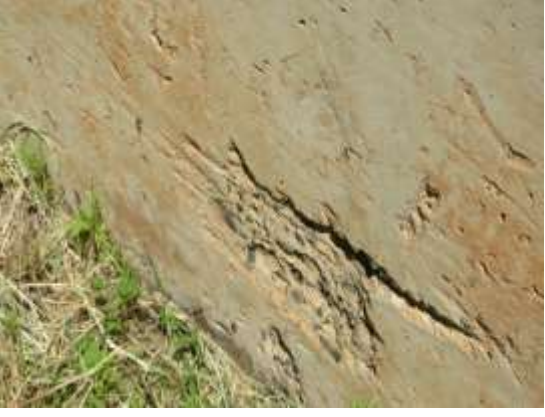
Left DER-U 232-2			
Right DER-U 222-3			
	Storm water runs over wall		
D = 3

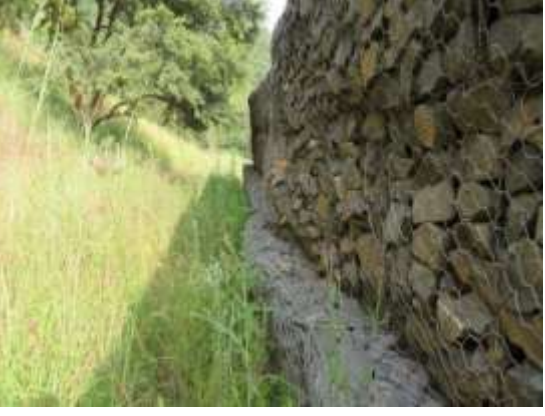
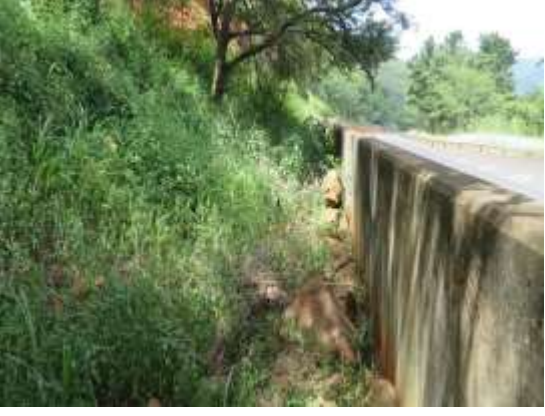
Left DER-U 333-1			
Right DER-U 332-1			
	Ext drainage blocked by vegetation	Material behind wall	
D = 4			
Left DER-U			
Right DER-U

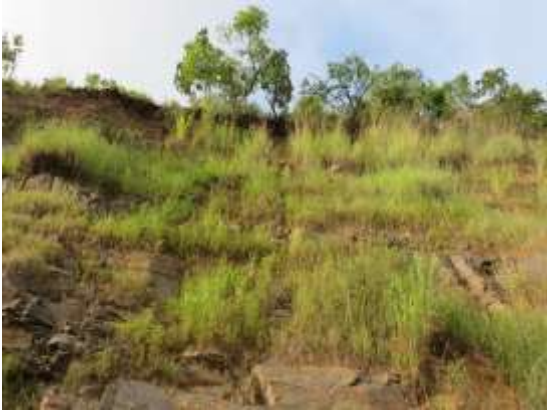
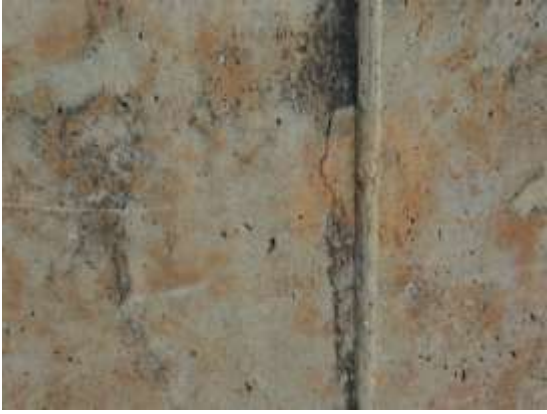
Left DER-U 111-0		
Right DER-U 132-2		
	Slope erosion	Repair cracks
D = 2

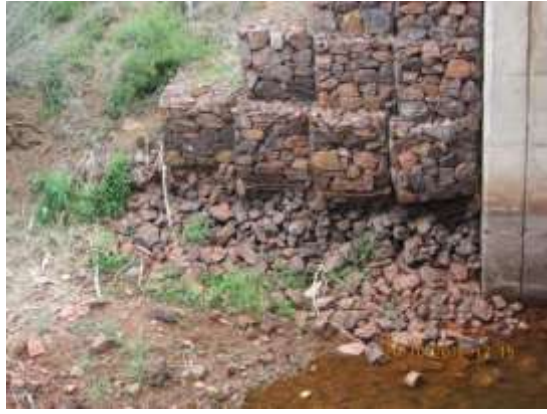
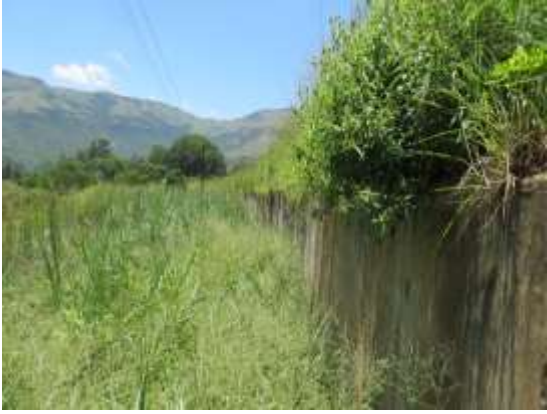
Left DER-U 222-2		
Right DER-U 242-1		
	Gabion failure	Clear bush
D = 3

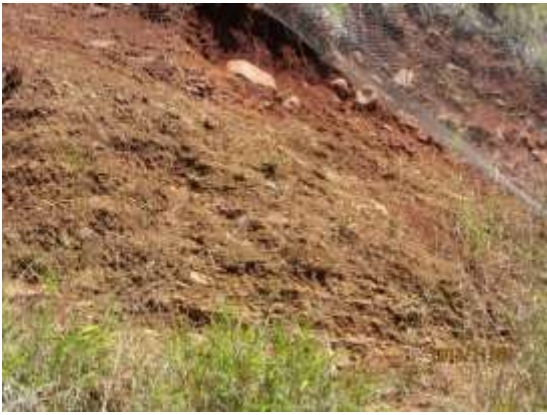
Left DER-U 312-1		
Right DER-U		
	Replace netting.	
D = 4

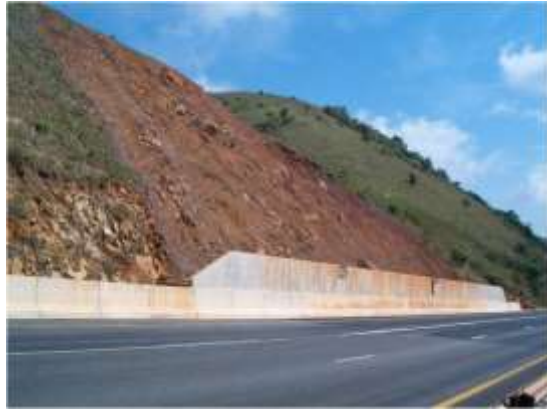
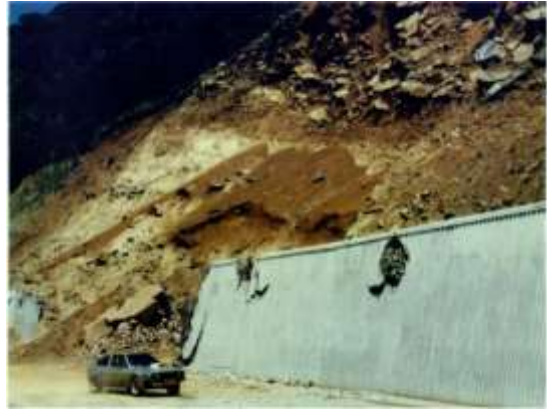
Left DER-U 443-3		
Right DER-U 423-4		
	Slope failure at wall. Damage due to rocks	Slope failure behind wall. Boulder damage.

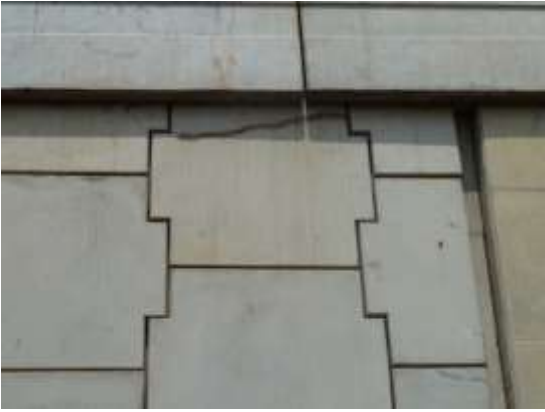
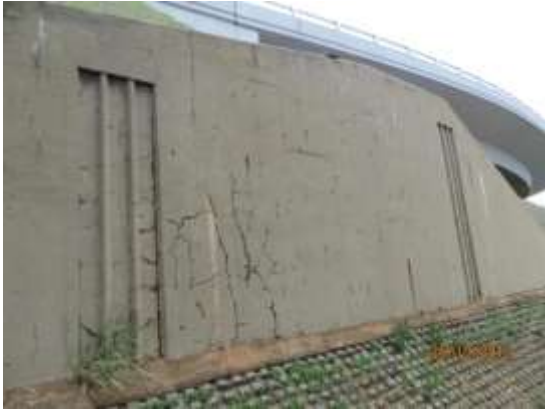
Left DER-U 111-2			
Right DER-U 131-2			
	Panel cracking	Cracks in concrete	
D = 2

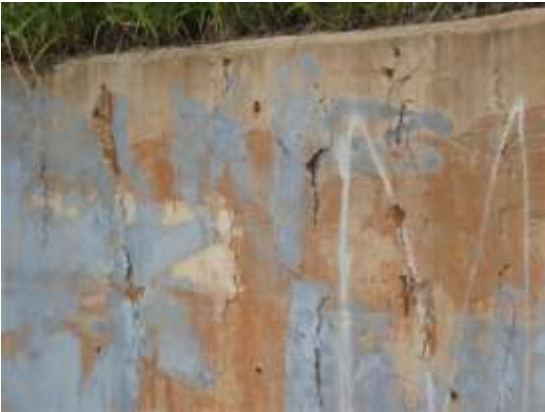
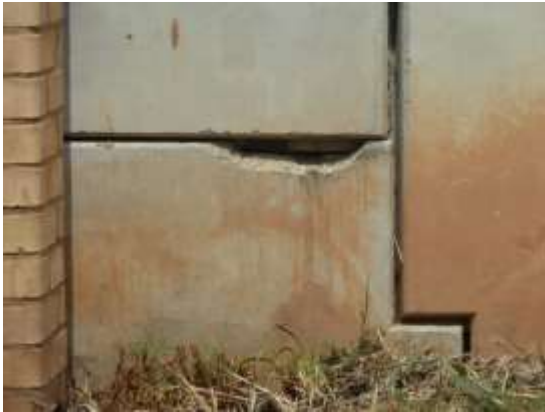
Left DER-U 232-3			
Right DER-U 211-1			
	Concrete spalls, inadequate cover to rebar	Spalled concrete	
D = 3

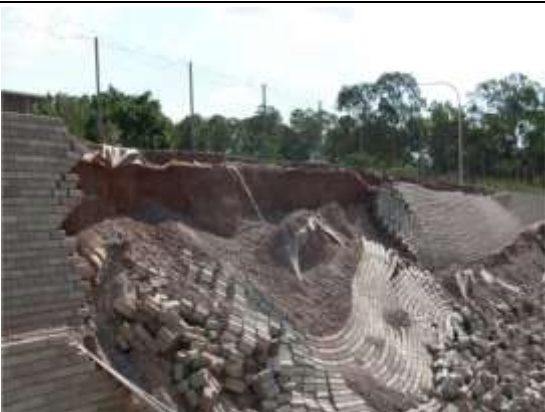
Left DER-U 444-4			
Right DER-U			
	Wall failure - reconstruct

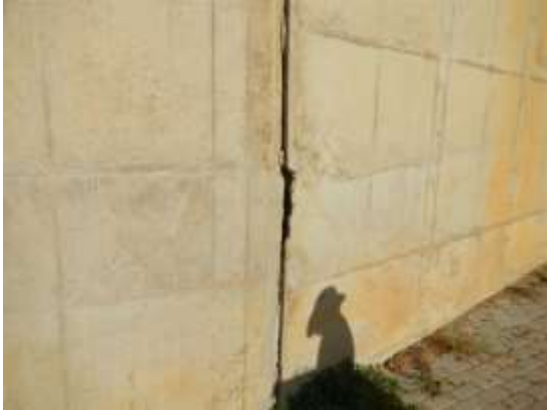
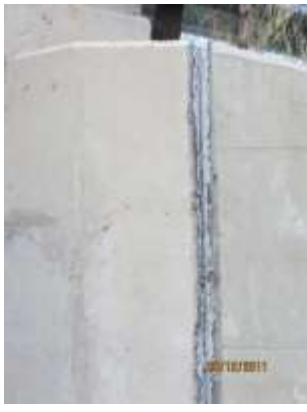
Left DER-U 121-1		
Right DER-U 121-2		
	Sealant starting to fail	Sealant starting to fail
D = 2

Item 4 Joint Defects		
Defect	Observations	D
Defective expansion joints	Crack developing between joint and adjoining surfacing.	1
	Spall in concrete adjacent to joint, accumulation of debris in joint impairing its proper functioning	2
	Seal loose	3
	Seal missing	4

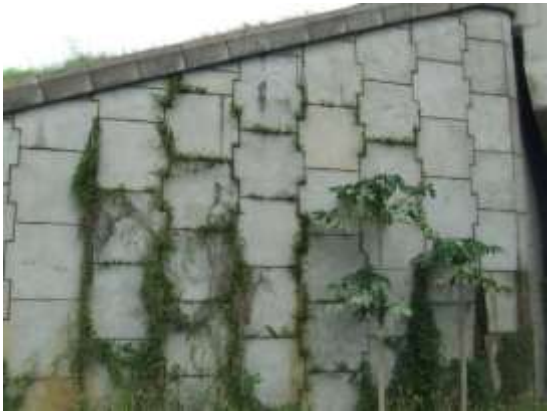
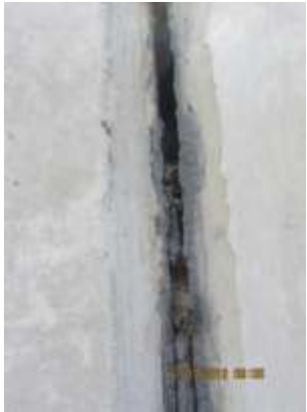
Left DER-U 242-2		
Right DER-U 222-2		
	Vegetation in joints	Joint sealant failure
D = 3

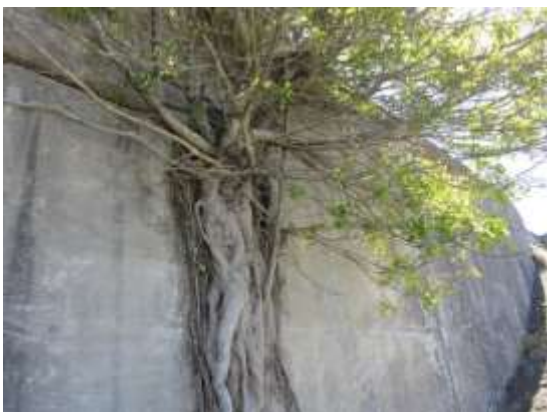
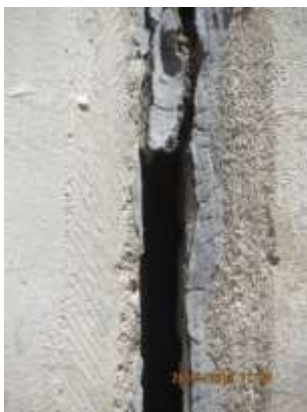
Left DER-U 313-3		
Right DER-U 323-2		
	Bushes growing from joint	Sealants have been removed
D = 4		
Left DER-U		
Right DER-U

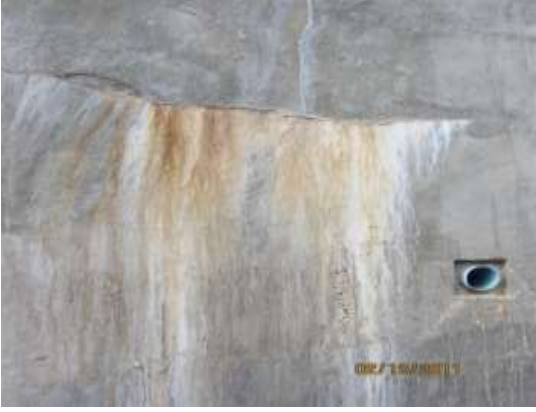
Left DER-U 111-2			
Right DER-U			
	No sign of subsurface drainage taking place		
D = 2			
Left DER-U			
Right DER-U			
D = 3			
Left DER-U			
Right DER-U			
D = 4			
Left DER-U			
Right DER-U

Item 5 Internal Drainage Defects		
Defect	Observations	D
Subsurface drainage not working	Minor	1
	Moderate	2
	Warning	3
	Severe	4
Subsurface drainage system not provided.  Stability problems could be expected if water build up occurs	Minor	1
	Moderate	2
	Warning	3
	Severe	4

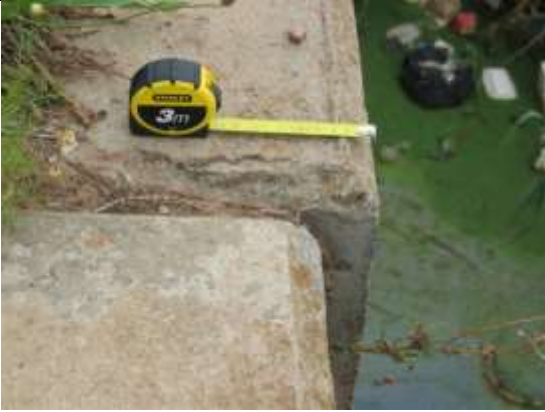
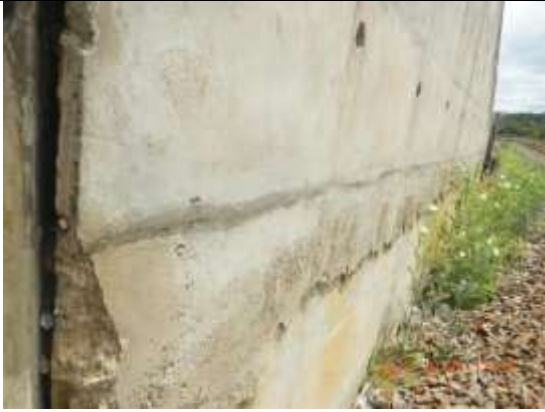
Left DER-U 121-1			
Right DER-U 121-2			
	Minor wall foundation rotation - note	Minor wall foundation rotation note	
D = 2

Item 6 Foundation Defects		
Defect	Observations	D
Wall movements and or rotations	Minor – note.	1
	Moderate – monitor.	2
	Warning – provide anchors.	3
	Severe – reconstruct.	4

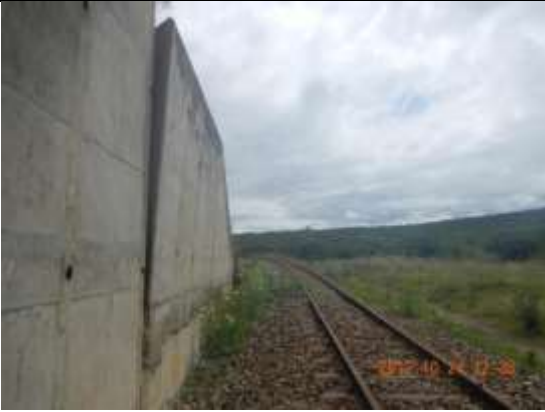
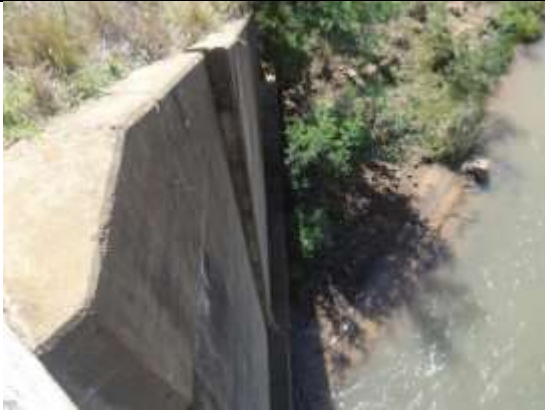
Left DER-U 222-2			
Right DER-U 222-2			
	Moderate wall foundation rotation - monitor	Moderate wall foundation rotation - monitor	
D = 3

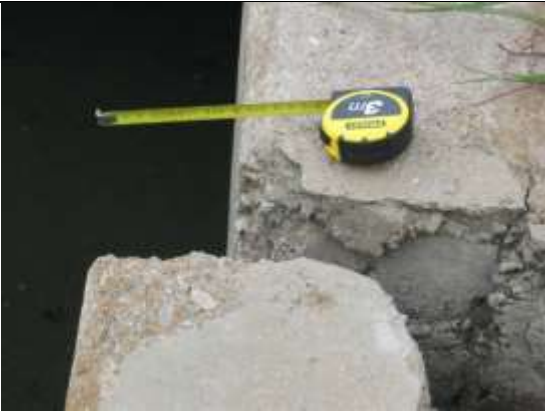
Left DER-U 333-3			
Right DER-U			
	Wall foundation rotation in warning state - anchor		
D = 4

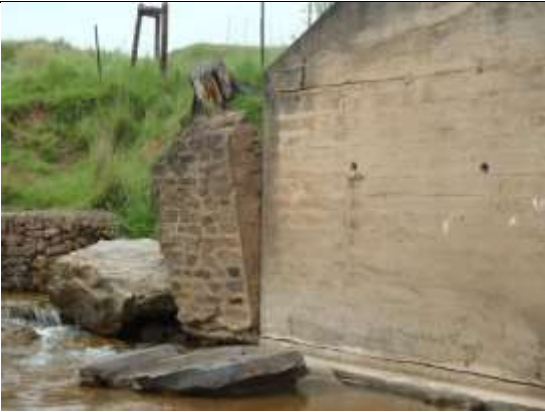
Left DER-U 423-3			
Right DER-U			
	Severe wall foundation rotation - reconstruct

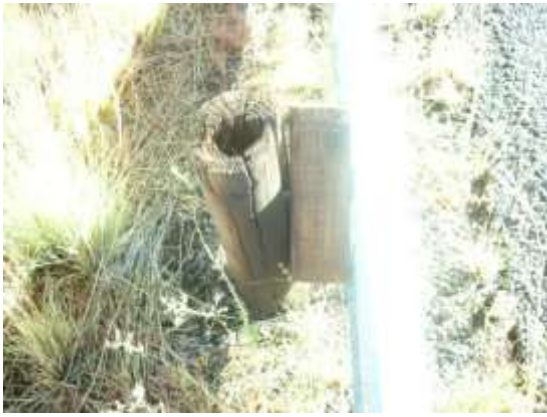
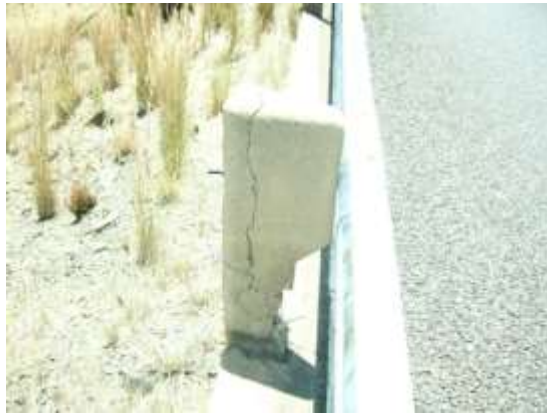
Left DER-U 111-2			
Right DER-U 111-2			
	Guardrail post rotten and weathered	Guardrail post cracked	
D = 2

<b>Item 1 Guardrail Defects</b>		
<b>Defect</b>	<b>Observations</b>	<b>D</b>
Defective guardrail	Guardrail posts are cracked or broken.	1-2
	Guardrail posts are missing.	2-3
	Bolts/nuts are loose.	1-2
	Nuts are missing.	1-2
	Wood spacer blocks are misaligned.	1-2
	Wood spacer blocks are missing.	2-3
	Guardrails are damaged, bent or broken.	1-4
	Guardrails are corroded.	2-3
	Laps need to be reversed.	3

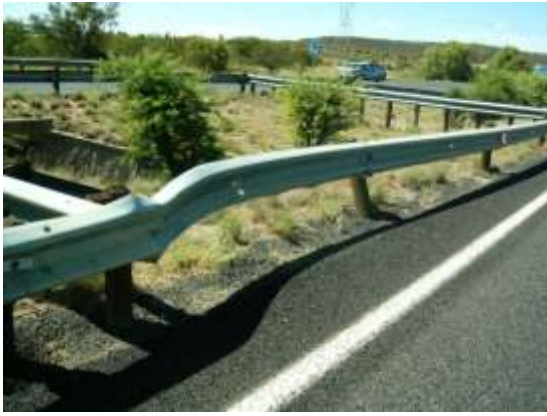
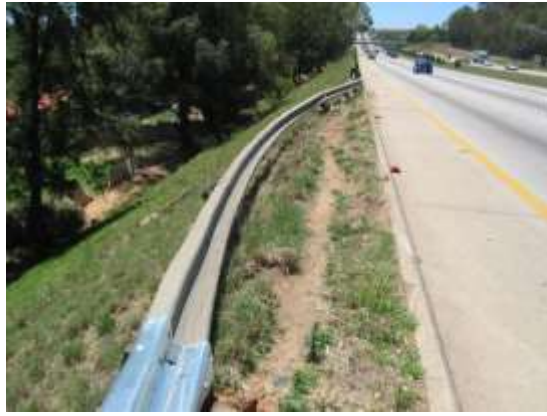
Left DER-U 211-3			
Right DER-U 222-3			
	Guardrail damaged by collision	Guardrail damaged by collision	
D = 3

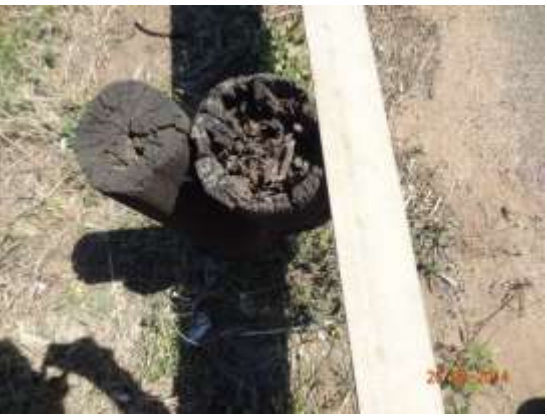
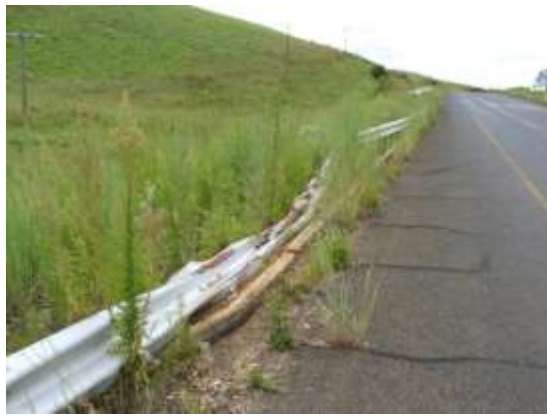
Left DER-U 311-1			
Right DER-U 322-3			
	Post spacer rotting	Guardrail damaged by collision	
D = 4

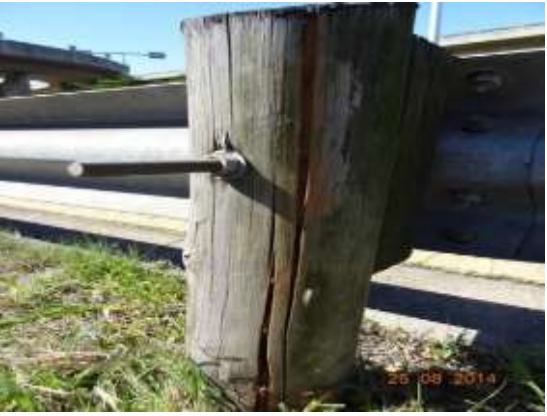
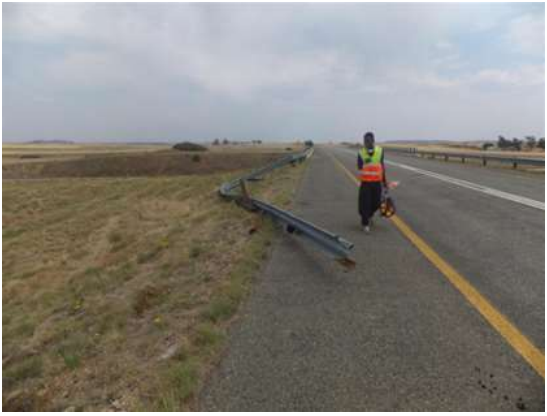
Left DER-U 422-3			
Right DER-U 423-4			
	Posts rotted and broken	Guardrail damaged by collision (MS)

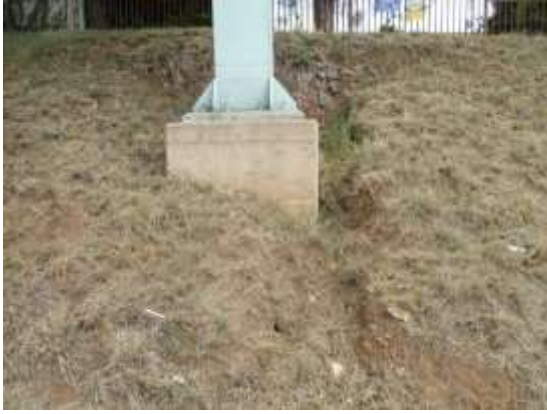
Left DER-U 121-1			
Right DER-U			
	Scour around foundation plinth		
D = 2

<b>Item 2 Foundation Defects</b>		
<b>Defect</b>	<b>Observations</b>	<b>D</b>
Concrete Defects	Spalls and honeycombing	1-4
	Lack of cover to reinforcement	1-3
	Concrete cracks	1-3
Scour and erosion defects	Minor	1
	Moderate	2
	Warning	3
	Severe	4
Structure number	Missing or illegible number	2
Foundation rotations	Minor to moderate	3
	Warning to severe	4

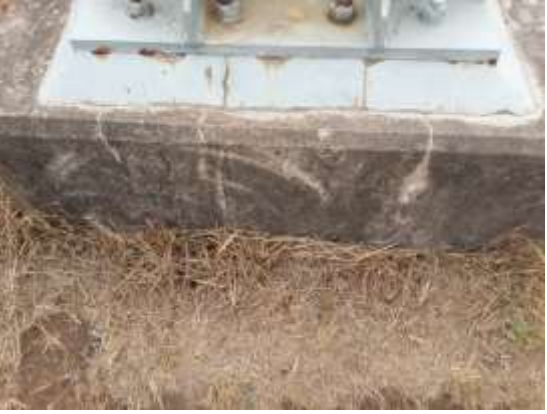
Left DER-U 221-3			
Right DER-U			
	Minor cracks		
D = 3			
Left DER-U			
Right DER-U			
D = 4			
Left DER-U			
Right DER-U

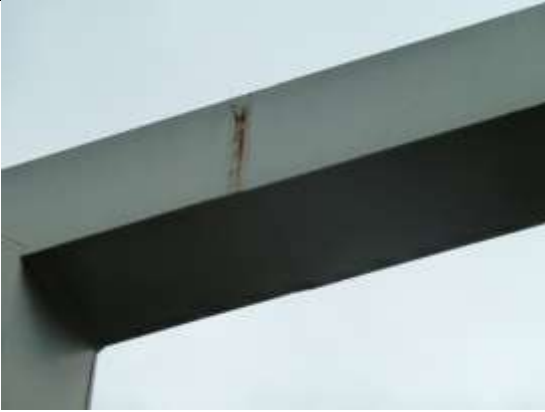
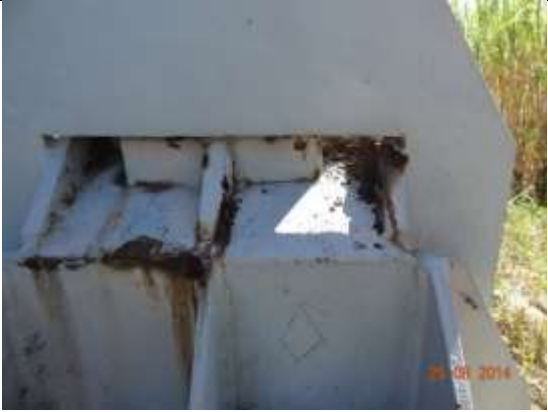
Left DER-U 111-1			
Right DER-U 111-2			
	Minor corrosion	Rust-repaint member	
D = 2

<b>Item 5 Horizontal Member Defects</b>		
<b>Defect</b>	<b>Observations</b>	<b>D</b>
Steel corrosion	Minor	1
	Moderate	2
	Warning	3
	Severe	4
Damaged steel beam	Minor	1
	Moderate	2
	Warning	3
	Severe	4
Missing bolts	Minor	1
	Moderate	2
	Warning	3
	Severe	4

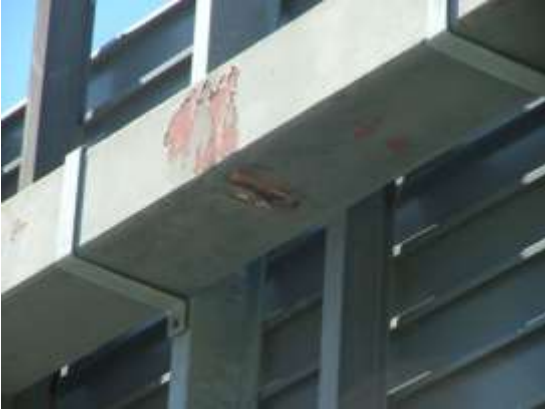
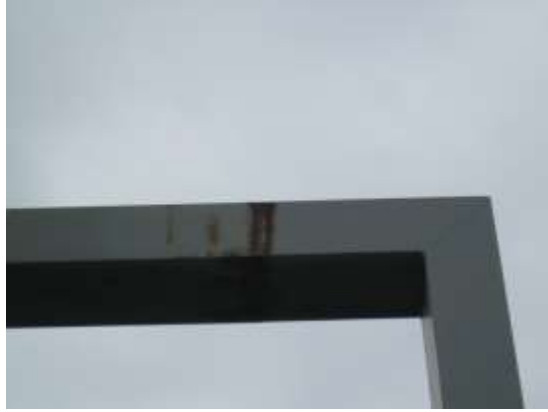
Left DER-U 222-2			
Right DER-U 223-3			
	Moderate corrosion	Site weld corrosion	
D = 3

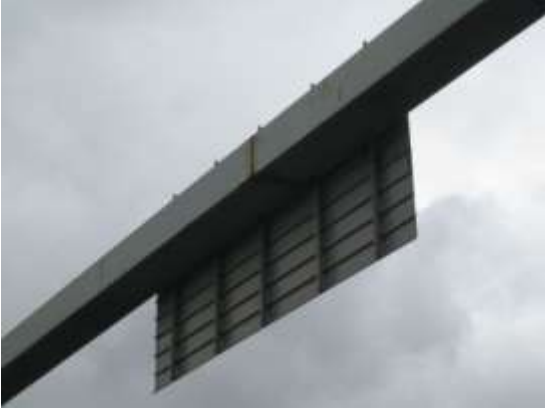
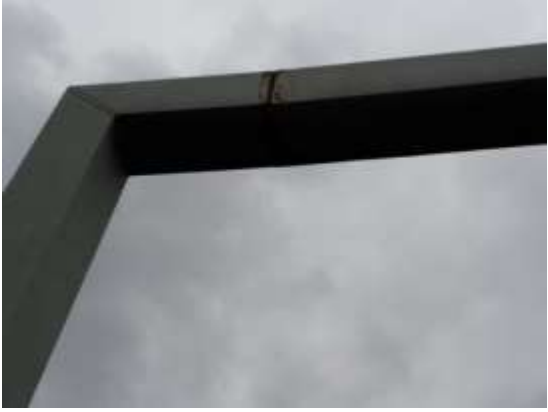
Left DER-U 313-4			
Right DER-U 333-3			
	Site weld at midspan corrosion	Member rusting, slight damage to alignment	
D = 4			
Left DER-U			
Right DER-U

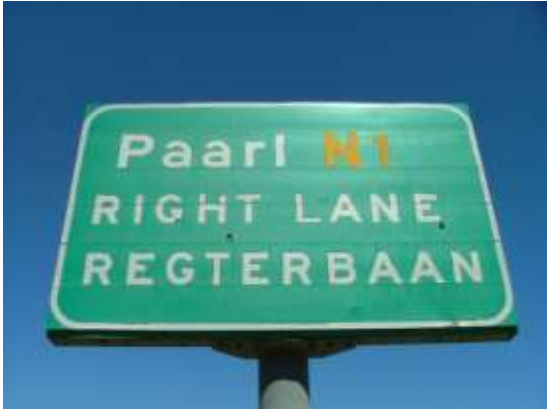
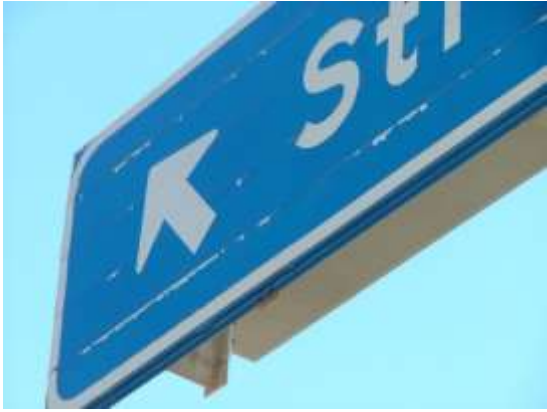
<p>Lettering starting to decay and peel away</p> <p>Blue background starting to deteriorate</p>
Left DER-U 121-1			
Right DER-U 121-2			
D = 2

<b>Item 6 Sign Face Defects</b>		
<b>Defect</b>	<b>Observations</b>	<b>D</b>
Vegetation growth	Trees/bushes in front of sign face making sign difficult to read	1-2
Unclear or damaged lettering.  Lettering has been removed.	Minor	1
	Moderate	2
	Warning	3
	Severe	4
Damaged steel sign face	Minor	1
	Moderate	2
	Warning	3
	Severe	4
Missing bolts or nuts that link sign profile sections	Minor	1
	Moderate	2
	Warning	3
	Severe	4
