**TMH19**

**MANUAL FOR THE VISUAL  
ASSESSMENT OF ROAD  
STRUCTURES**

**PART B: VISUAL ASSESSMENT GUIDE**

**August 2020**

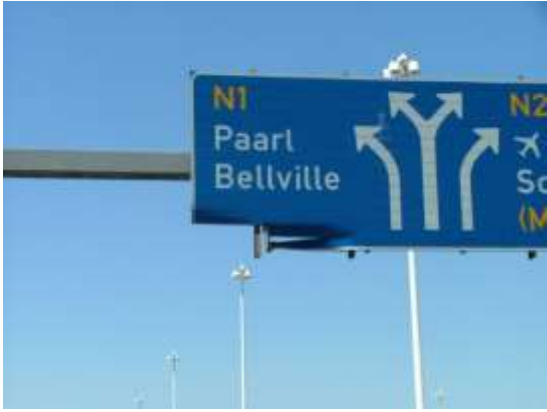
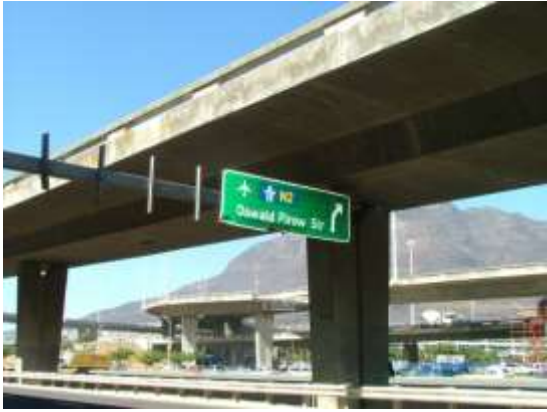
<p>Sign face damaged - increase vert. clearance</p> <p>Sign face damaged - increase vert. clearance</p>
Left DER-U 212-3			
Right DER-U 222-3			
D = 3

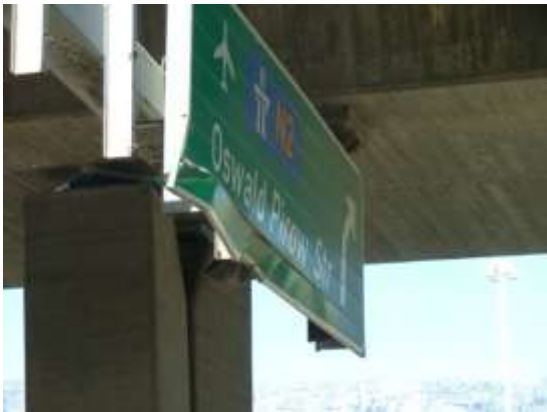
Left DER-U 333-3			
Right DER-U			
	Sign face damaged and removed		
D = 4

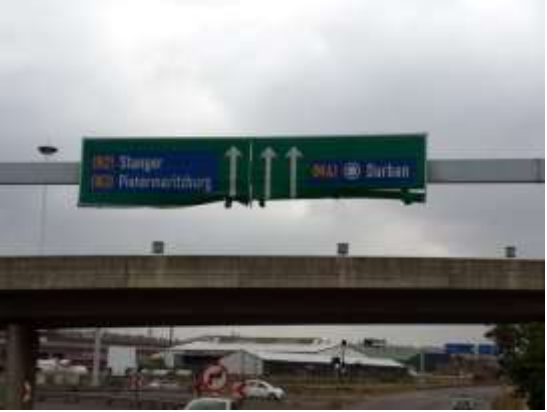
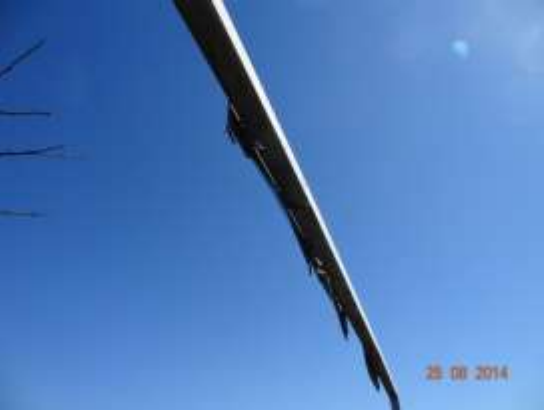
<p>Sign damaged from collision</p> <p>Sign damaged</p>
Left DER-U 434-4			
Right DER-U 434-4

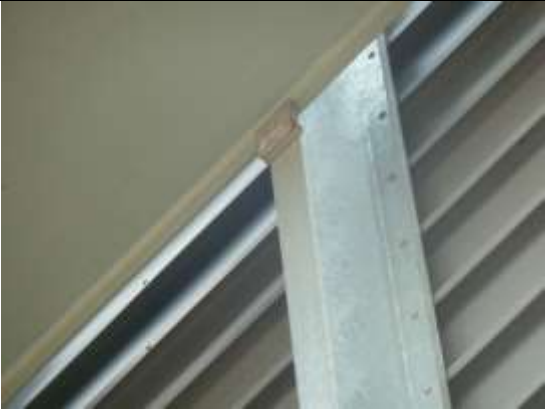
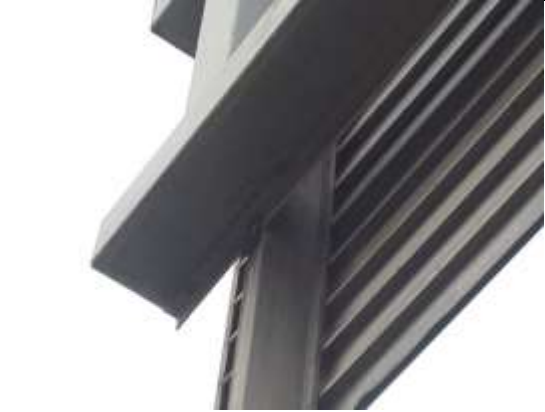
Item 7		Sign Fastener Defect Photos	
D = 1

Left DER-U 111-2			
Right DER-U 111-3			
	Fixing bracket slightly corroded	Rust-repaint	
D = 2

<b>Item 7 Sign Fastener Defects</b>		
<b>Defect</b>	<b>Observations</b>	<b>D</b>
Steel corrosion	Minor	1
	Moderate	2
	Warning	3
	Severe	4
Damaged steel fixing bracket.  Repair, strengthen or replace	Minor	1
	Moderate	2
	Warning	3
	Severe	4
Missing bolts and/or nuts	Minor	1
	Moderate	2
	Warning	3
	Severe	4

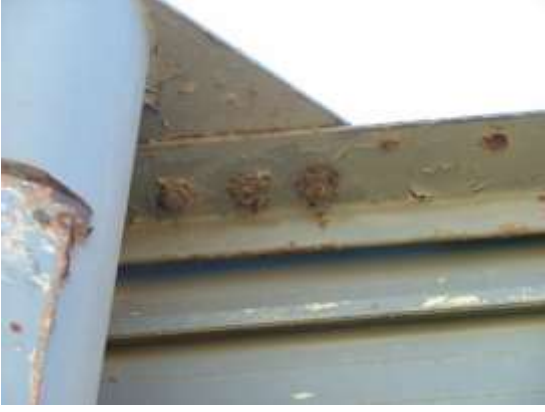
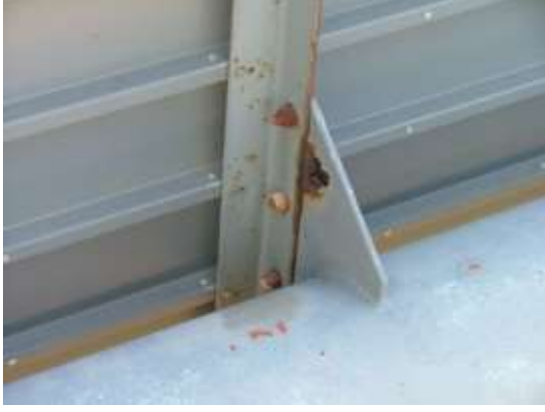
Left DER-U 232-2			
Right DER-U 232-3			
	Fixing bolts moderately corroded	Fixing bolts moderately corroded	
D = 3

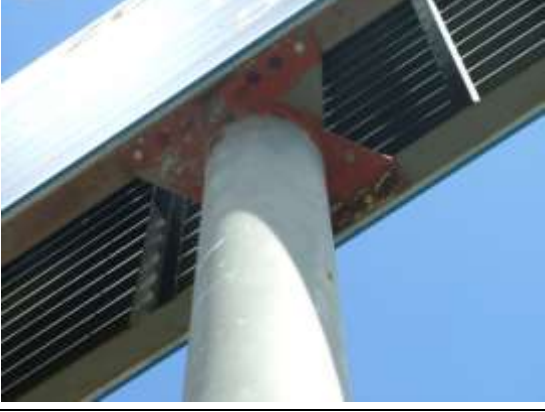
Left DER-U 323-3			
Right DER-U			
	Corrosion of fixing bracket and bolts in warning state		
D = 4

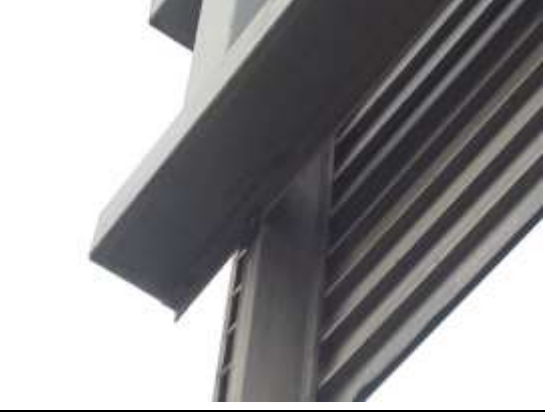
Left DER-U 434-4			
Right DER-U			
	Signboard fasteners damaged and rusting

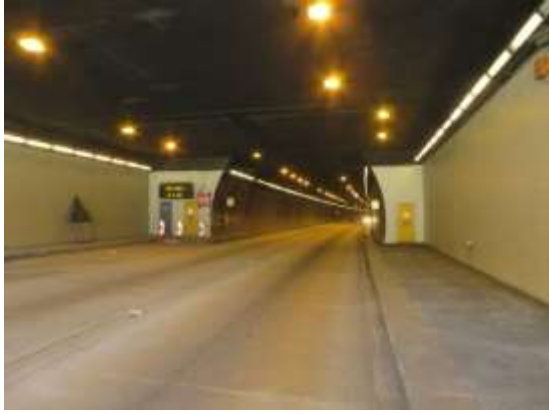
Item 1		Portal Defect Photos	
D = 1

Left DER-U 111-2			
Right DER-U			
	Clean Painted Concrete Surface		
D = 2			
Left DER-U			
Right DER-U			
D = 3

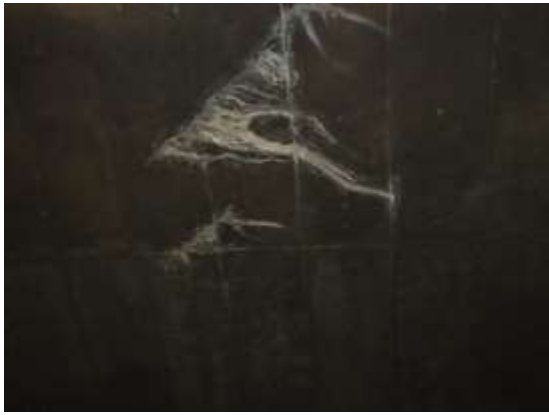
Left DER-U 324-2			
Right DER-U			
	Seal cracks		
D = 4			
Left DER-U			
Right DER-U

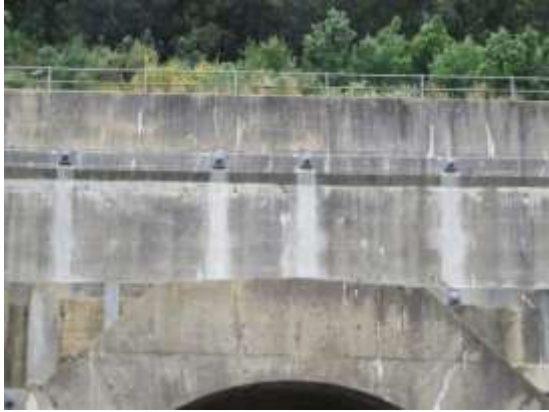
Item 2		Slope Protection Defect Photos	
D = 1			
Left DER-U			
Right DER-U			
D = 2

Left DER-U 222-2			
Right DER-U			
	Cracks, leaching		
D = 3			
Left DER-U			
Right DER-U			
D = 4			
Left DER-U			
Right DER-U

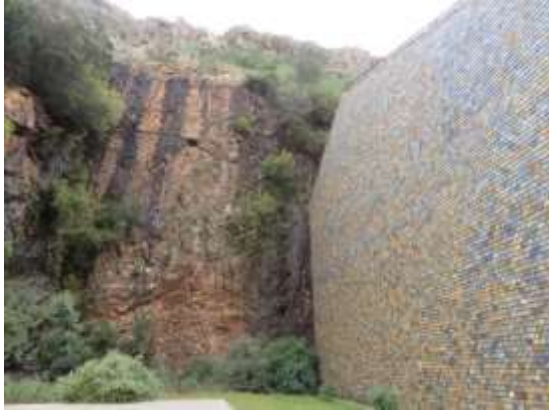
**Item 3 Rock Fall Defect Photos**

Left DER-U 222-R		
Right DER-U		
	Rock fall protection	
D = 3		
Left DER-U		
Right DER-U		
D = 4		
Left DER-U		
Right DER-U

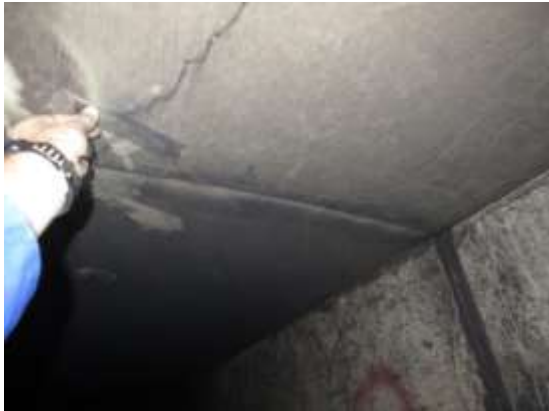
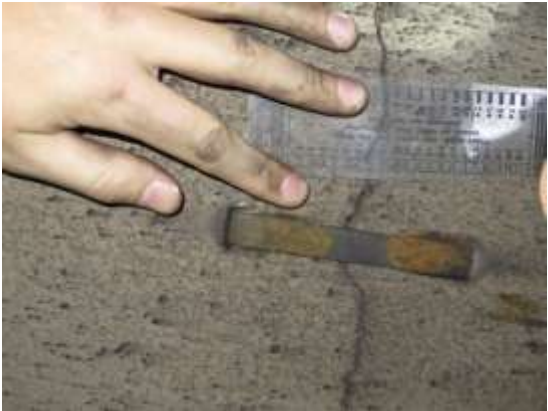
Item 6		Lining Defect Photos	
D = 1			
Left DER-U			
Right DER-U			
D = 2			
Left DER-U			
Right DER-U			
D = 3			
Left DER-U			
Right DER-U			
D = 4

Left DER-U 421-2			
Right DER-U 422-2			
	0.8 mm crack in ceiling	2 mm longitudinal crack in ceiling

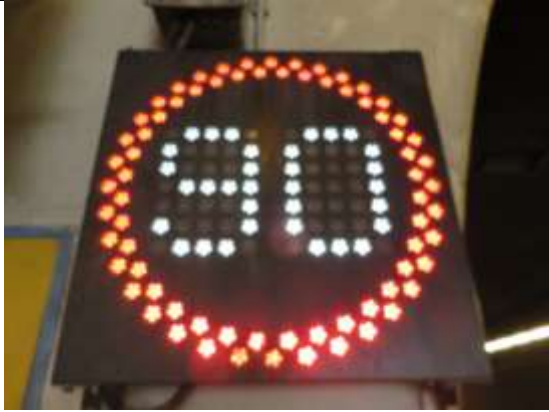
Item 8		Operational Defect Photos	
D = 1

Left DER-U 111-3			
Right DER-U			
		Replace traffic signs with LED signs	
D = 2

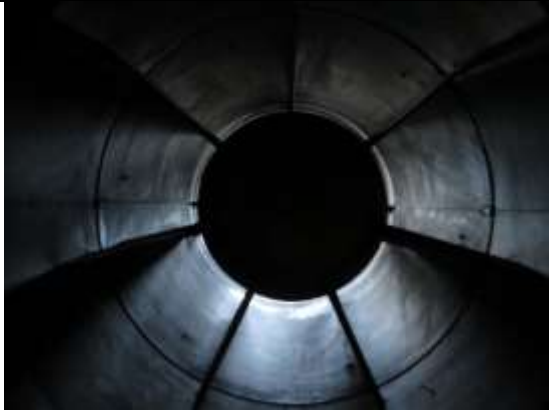
Left DER-U 243-2			
Right DER-U			
		Replace switchgear for fans	
D = 3			
Left DER-U			
Right DER-U			
D = 4			
Left DER-U			
Right DER-U

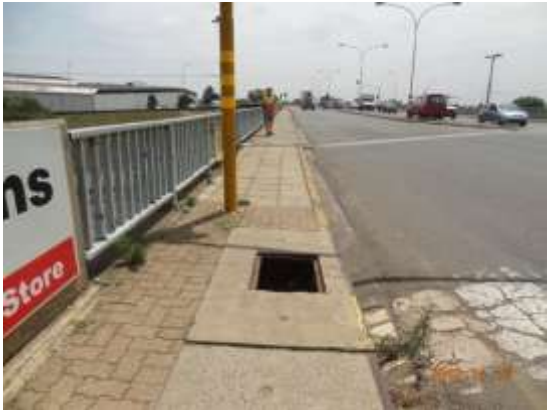
Left DER-U 424-4		
Right DER-U 414-4	Pavement layer undermined by stormwater	Manhole cover missing in pedestrian walkway
D = 4

If a defect is critical to the structural integrity such that collapse is imminent or where public safety risk is considered high, such a defect should be recorded as Make Safe (MS) and should receive immediate attention. The inspector should immediately alert the authorities to implement appropriate safety measures to ensure the safety of the user. Proof of the communication should be kept clearly indicating the authority and person(s) contacted.

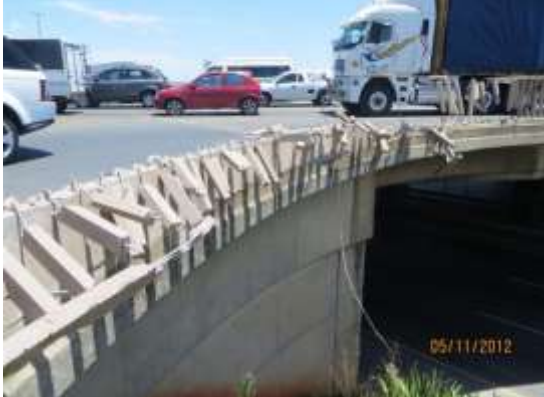
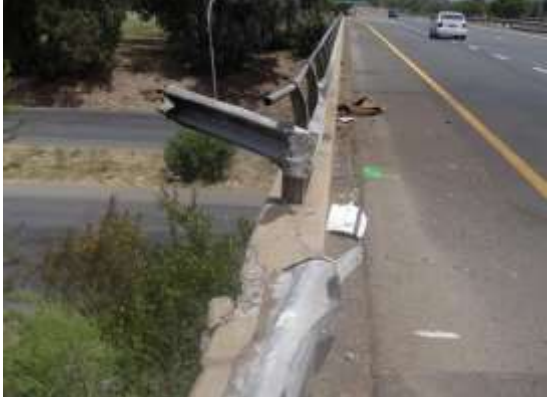
Left DER-U 434-4		
Right DER-U 424-4	Impact damage to parapet	Impact damage to parapet
D = 4

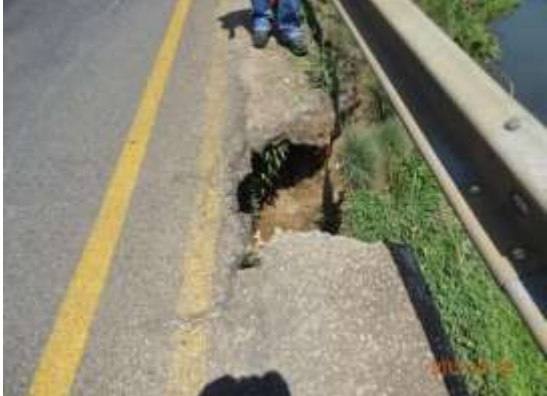
Left DER-U 424-4		
Right DER-U 424-4	Impact damage to parapet / end block	Severe erosion at approach embankment
D = 4

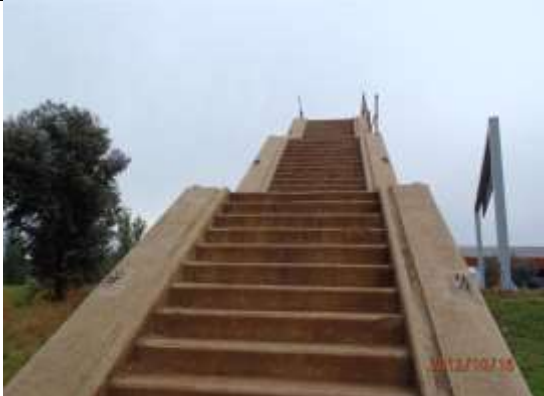
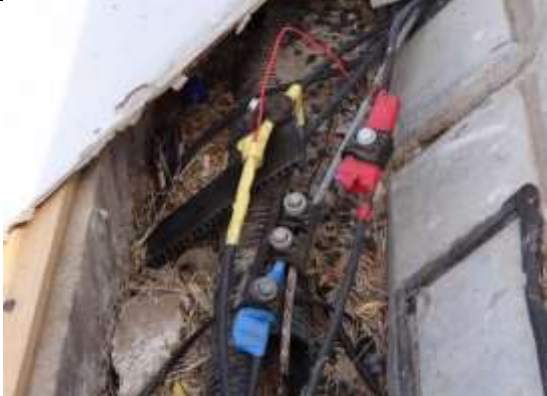
Left DER-U 444-4		
Right DER-U 414-4	Missing handrails on pedestrian bridge	Exposed live wiring on pedestrian walkway
