**TMH 9**

**MANUAL FOR VISUAL  
ASSESSMENT OF ROAD  
PAVEMENTS  
PART D: BLOCK PAVEMENTS**

**Committee Draft Final  
May 2016**

**Committee of Transport Officials**

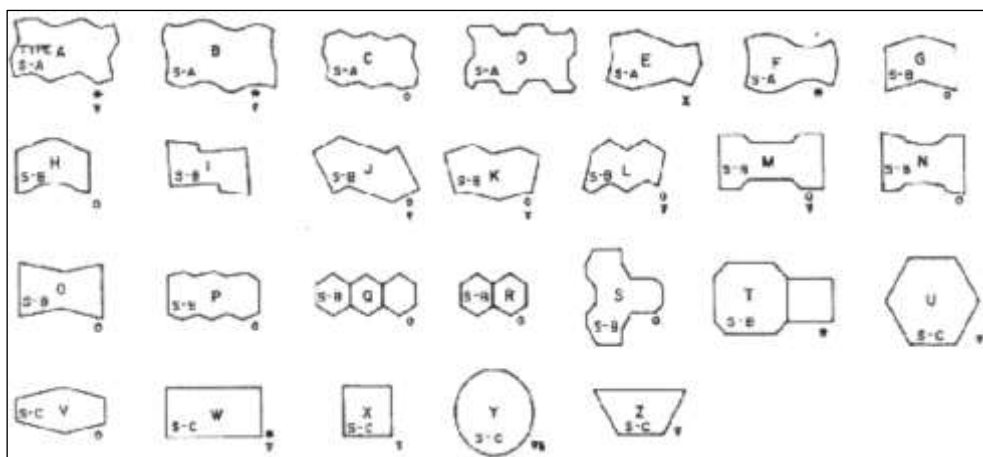
**Figure D.1: Illustration of paving block shapes**

The block pavers shape code is based on the degree of interlock that can be achieved between vertical faces of adjacent blocks, and is given in Table D.1, and illustrated in Figure D.1.

Code	Description
S-A	Blocks which allow geometrical interlock between <b>ALL</b> vertical faces of adjacent blocks.
S-B	Blocks which allow geometrical interlock between some faces of adjacent blocks.
S-C	Blocks which allow no geometrical interlock between adjacent faces.

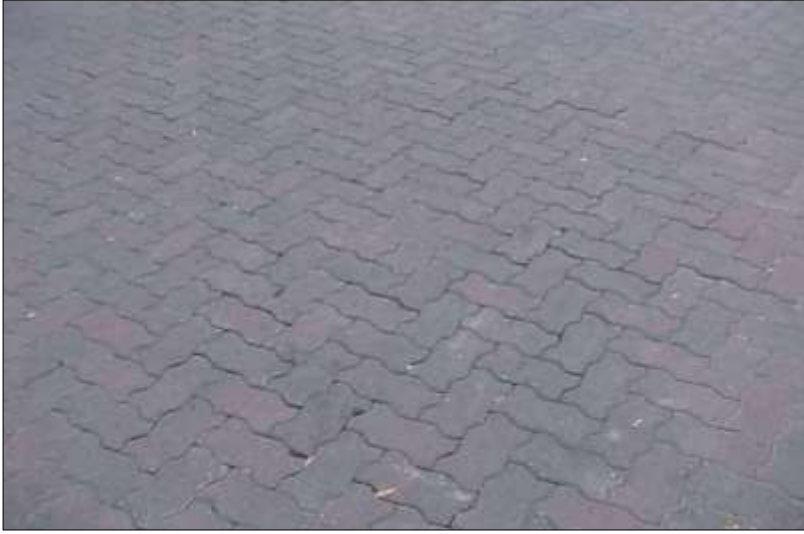
1				
	X	2	3	4	5
	Single cracks or chips per block

Degree	Description
1	Single cracks or chips per block with minimal spalling at cracks.
3	More than one crack or chip occurring on individual blocks, and spalling at cracks.
5	Shattered blocks losing parts of the blocks.

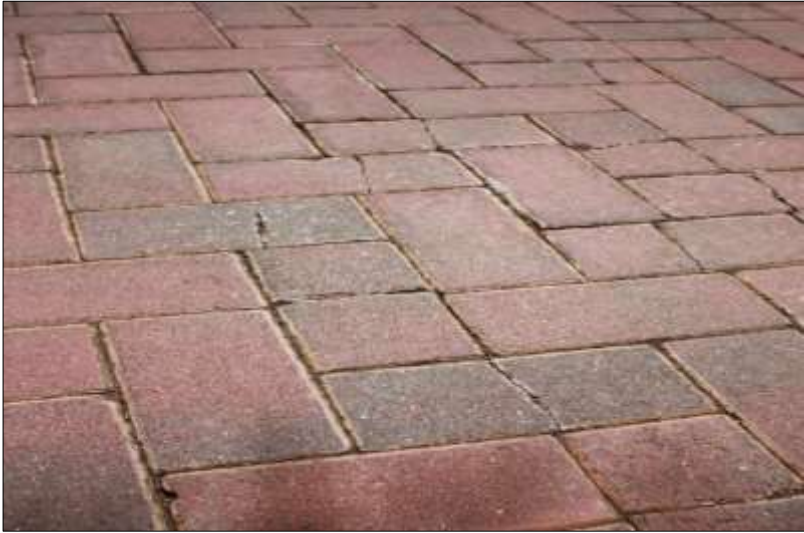
3				
	1	2	X	4	5
	More than one crack or chip per block

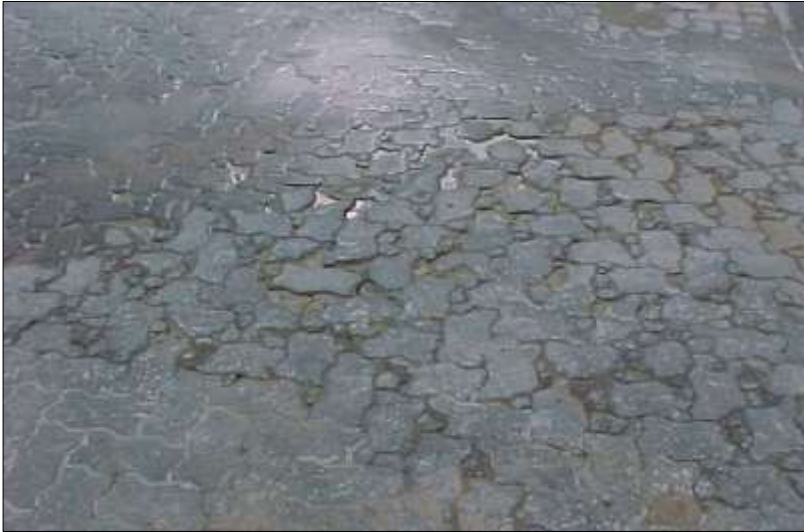
5				
	1	2	3	4	X
	Shattered blocks

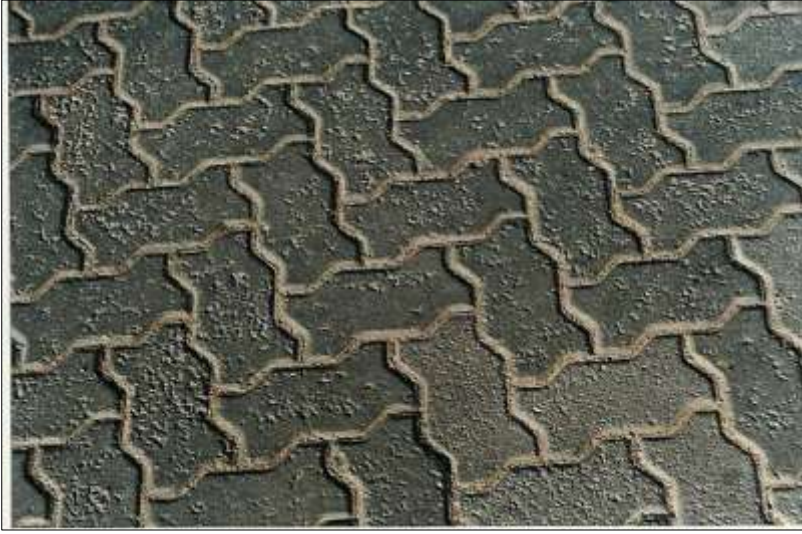
1				
	X	2	3	4	5
	Minimal evidence of wear

Degree	Description
1	Minimal evidence of wear visible.
3	Evidence of aggregate loss on surface, and some loss of the chamfer profile.
5	Rounding of the upper block surface as a result of severe aggregate loss.

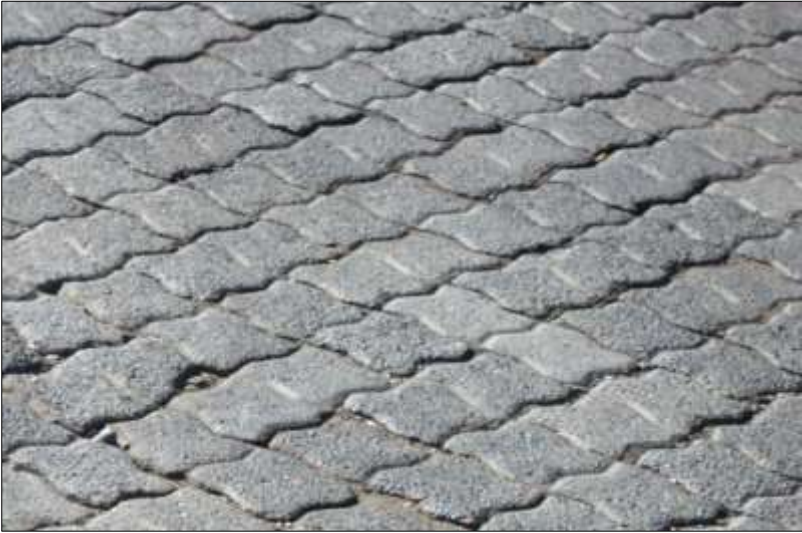
3				
	1	2	X	4	5
	Some evidence of surface aggregate loss and chamfer wear

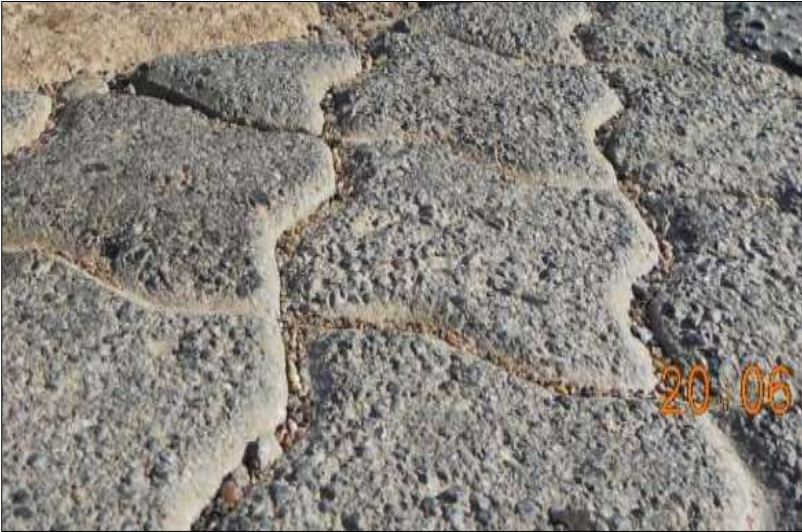
5				
	1	2	3	4	X
	Rounding of upper surface of block through wear

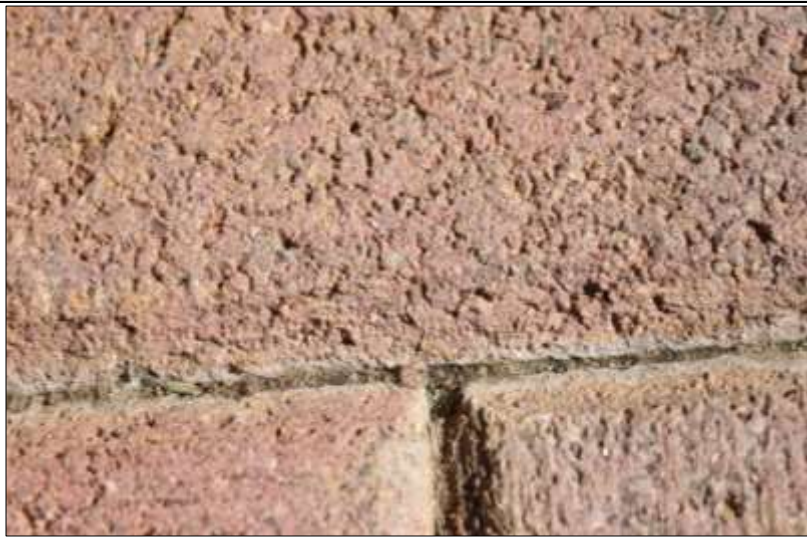
1				
	X	2	3	4	5
	Jointing sand less than 10 mm below block surface

Degree	Description
1	The jointing sand is less than 10 mm below the surface of the blocks, and the block paving is integral and has achieved lock-up.
3	Jointing sand is more than 20 mm below the surface of the blocks. Paving blocks loose lock-up and joints widen with differential levels between blocks. Blocks move under loading and pumping occurs.
5	A limited amount of jointing sand present in the joints, joint widths are variable and the blocks can be rocked by standing on them. The levels of adjacent blocks are not even and pumping occurs.

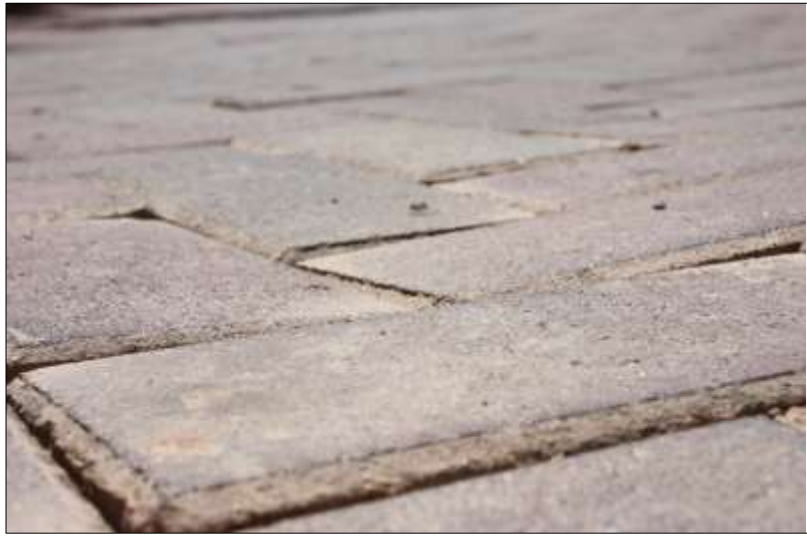
3				
	1	2	X	4	5
	Jointing sand more than 20 mm below block surface. Blocks move.

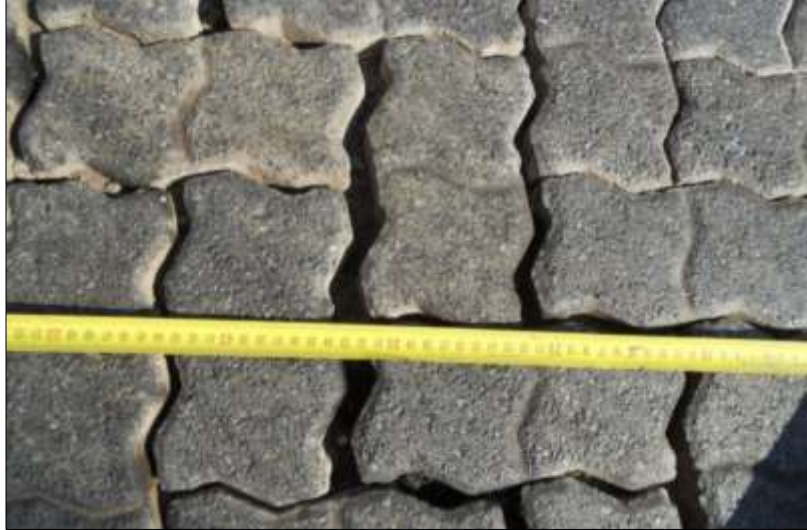
5				
	1	2	3	4	X
	Little jointing sand between blocks, which move and are not even. May pump.

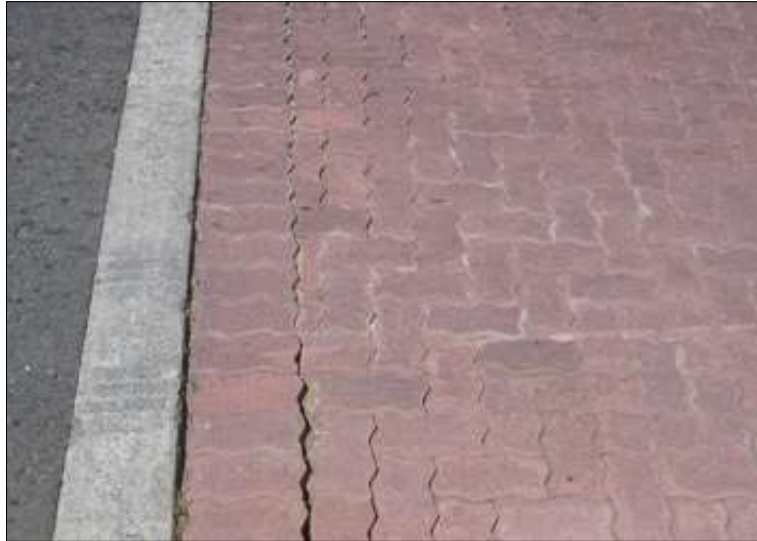
**Figure D.3: Pumping adjacent to edge restraint as a result of poor drainage**

Edge restraints consist of kerbing, channels or other similar edge strips, or anchor beams on steep gradients to prevent downhill creep of the paving blocks. The objective of edge restraints is to prevent any lateral movement of pavers located along the edge of the pavement. This ensures that the overall integrity of the pavement is maintained. Edge restraints or anchor beams must not trap water, and should have drainage holes at the level of the bedding sand. Sections displaying lack of drainage show up as pumping adjacent to the edge restraint or beam, as shown in Figure D.3. The pavement defects would be listed under loss of jointing sand.

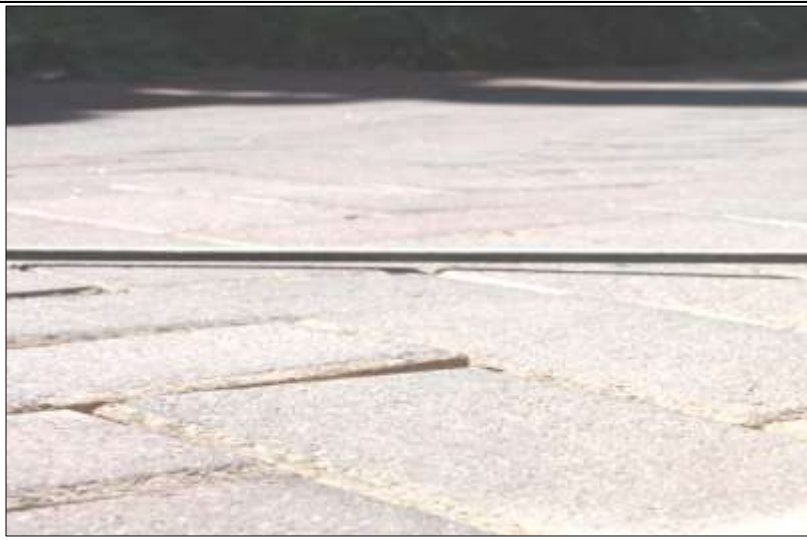
1					
	<table border="1" style="width: 100%;"> <tr> <td style="text-align: center;">X</td> <td style="text-align: center;">2</td> <td style="text-align: center;">3</td> <td style="text-align: center;">4</td> <td style="text-align: center;">5</td> </tr> </table>	X	2	3	4	5
	X	2	3	4	5	
<p>Rutting present but difficult to discern. &lt; 5 mm</p>

Degree	Description
1	Difficult to discern unaided. Deformation under a 2m straight edge is less than 5 mm.
3	Readily discernible, and typically between 10 and 15 mm under a 2 m straight edge.
5	Severe and dangerous, with rutting exceeding 25 mm under a 2 m straight edge.

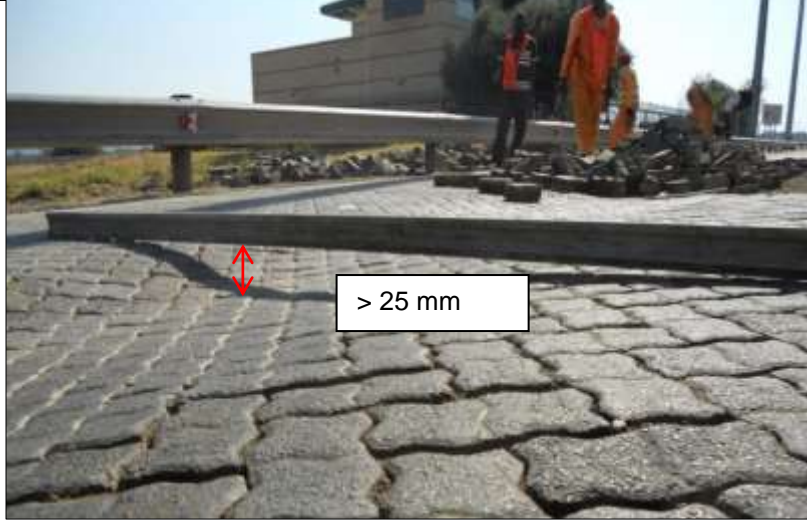
1	2	3	4	X	
<p>Rutting severe and dangerous. &gt; 25mm deep.</p>

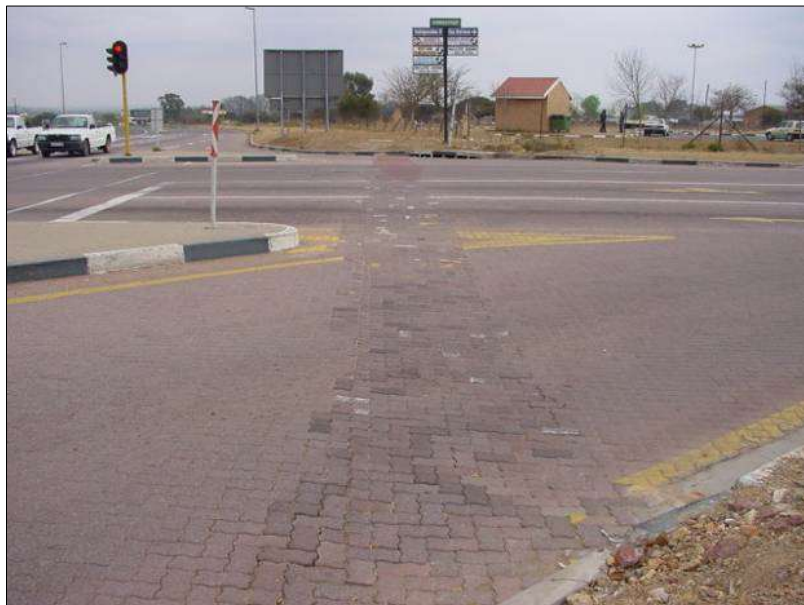
**Figure D.4: Noticeable trench reinstatement on a block pavement**

Occasionally a service trench reinstatement is noticeable and could be the source of distress different from the general pavement. Figure D.4 shows such an example.
